FACTORY POND DAM
PHASE I
INSPECTION / EVALUATION REPORT

Dam Name: **Factory Pond Dam**
State Dam ID#: **7-12-123-2**
NID ID#: **MA00391**
Owner: **Town of Hanover / Town of Hanson**
Town: **Hanover / Hanson**
Consultant: **Amory Engineers, P.C.**
Date of Inspection: **December 22, 2011**

Dam Evaluation Summary Detail Sheet

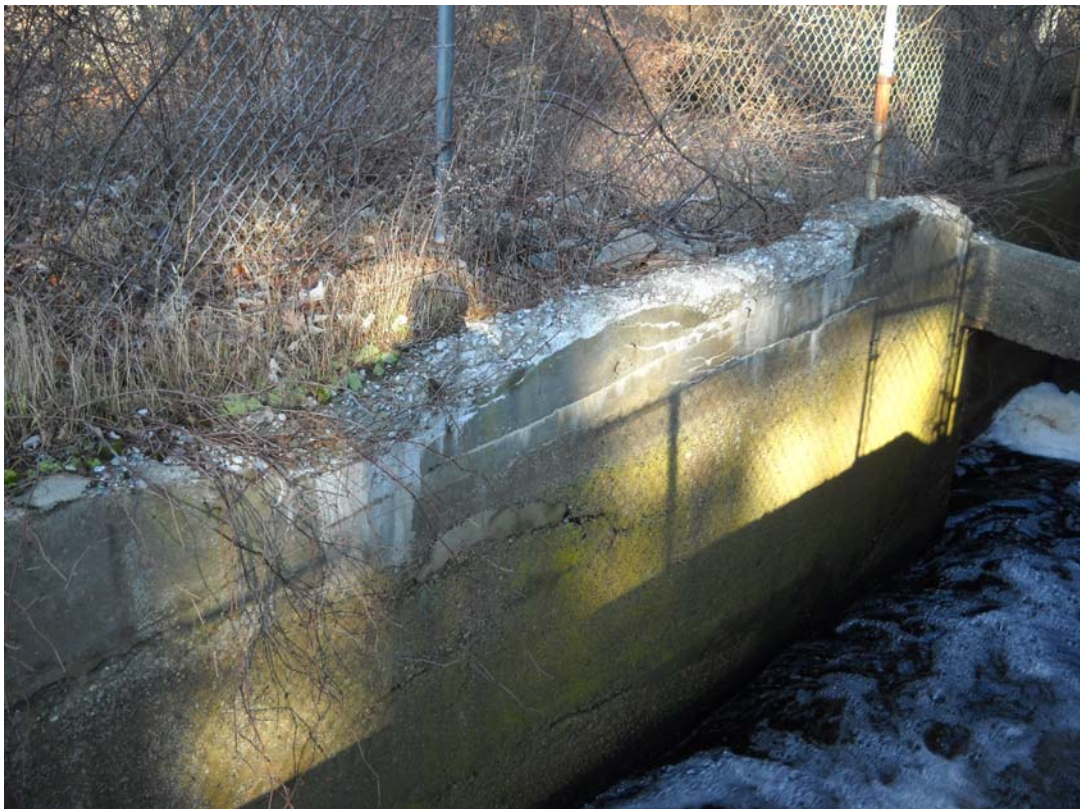
1. The primary spillway concrete walls have significant cracks, spalled concrete and exposed aggregate.
 2. Trees, dense brush and roots on the dam crest, the upstream and downstream embankment slopes and along the toe of the embankment left of the auxiliary spillway.

Photo 21A – Spalled concrete on left outlet channel wall

5. Repair cracks and spalls in concrete.
 6. Replace and/or reset riprap stone on downstream face of the auxiliary spillway right contact.
 7. Repair downstream vertical fieldstone retaining wall.

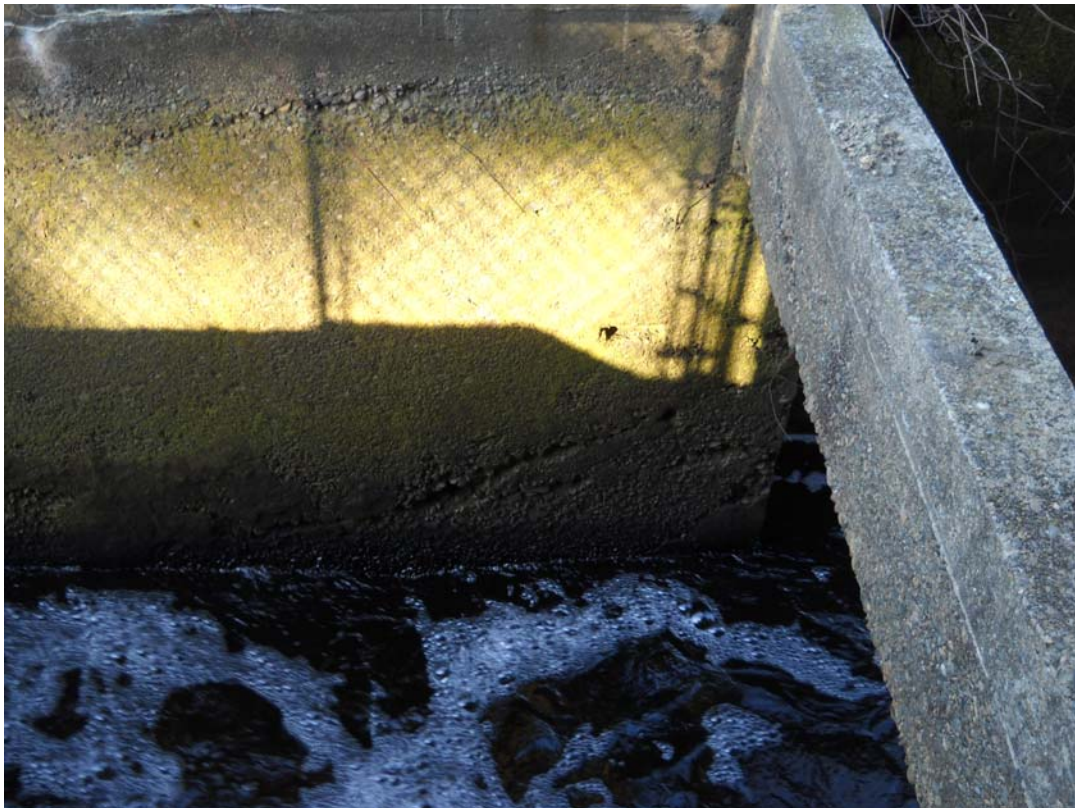
Photo 21B – Exposed aggregate/deteriorated concrete on left outlet channel wall

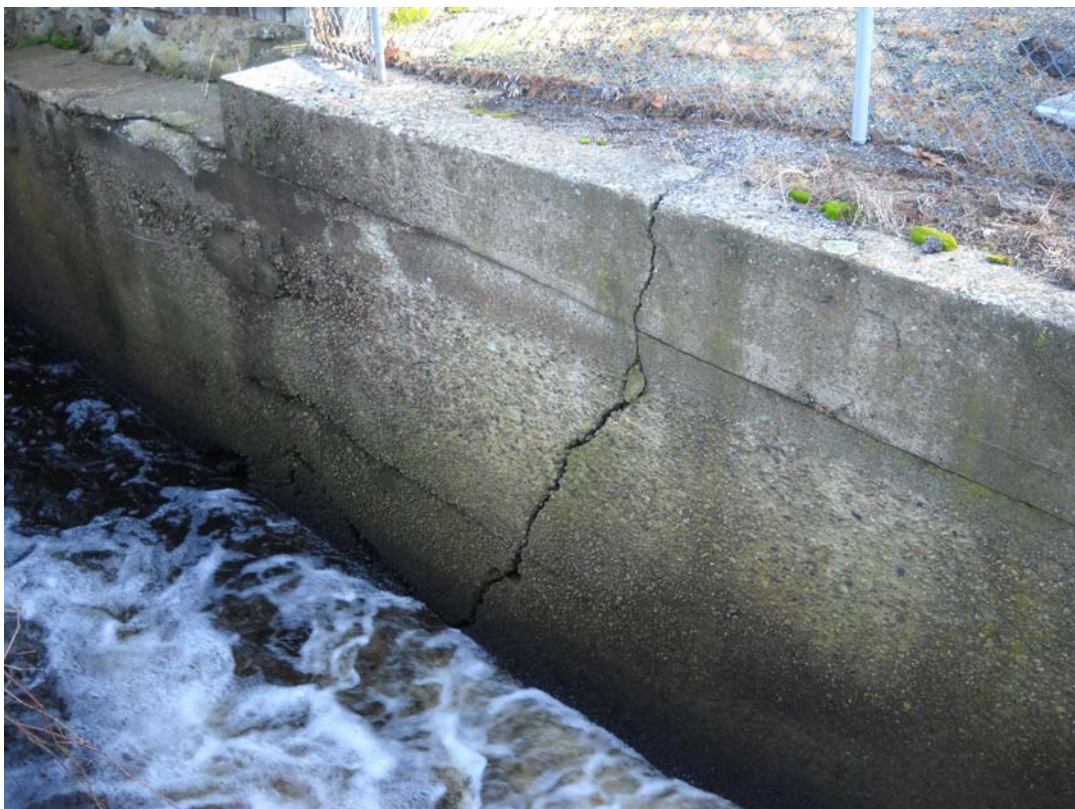
Cracks in the right concrete wall of the discharge channel are a concern. The extent of the cracks should be investigated and the wall should be monitored for movement.

Photo 21C – Cracks in right outlet channel wall

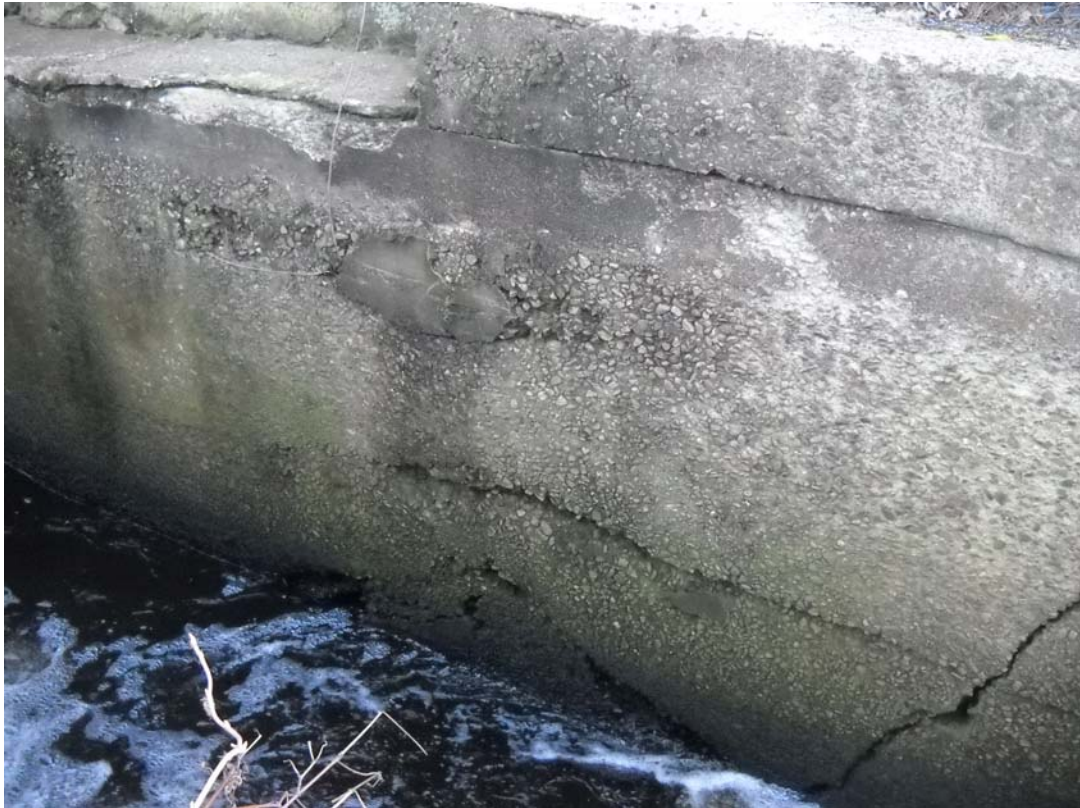
Photo 21D – Cracks in right outlet channel wall

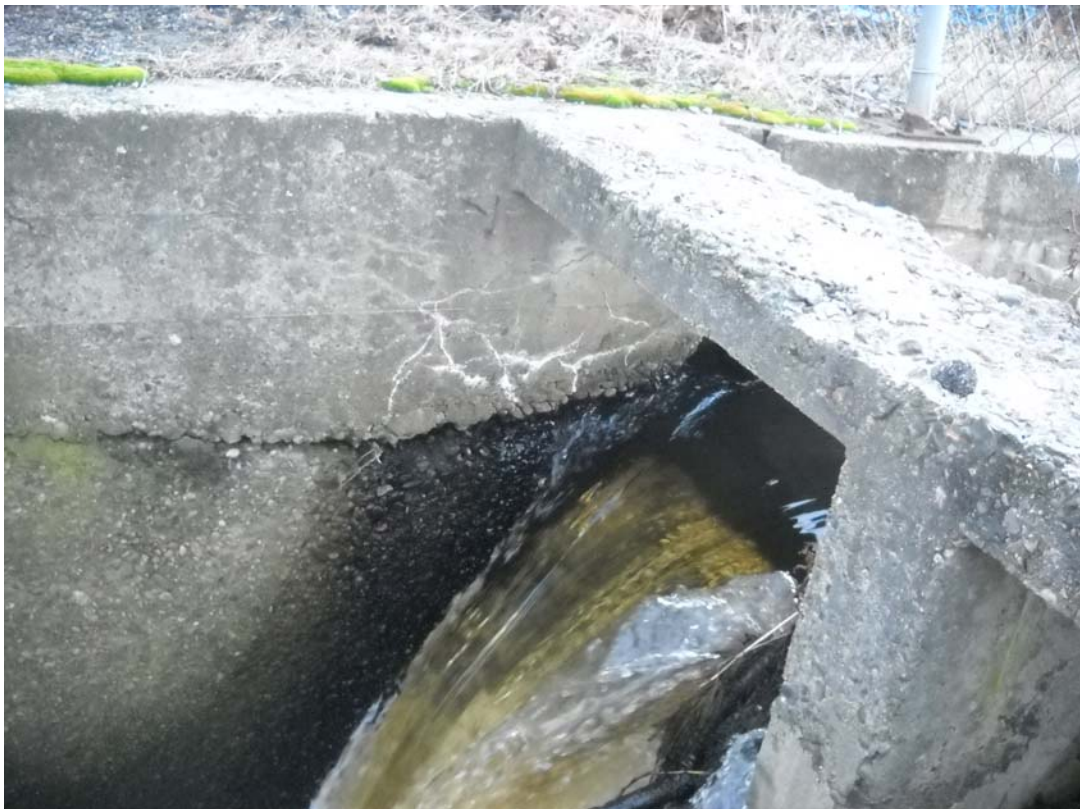
Photo 21E – Crack in wall at right of weir (note spalled concrete on beam)

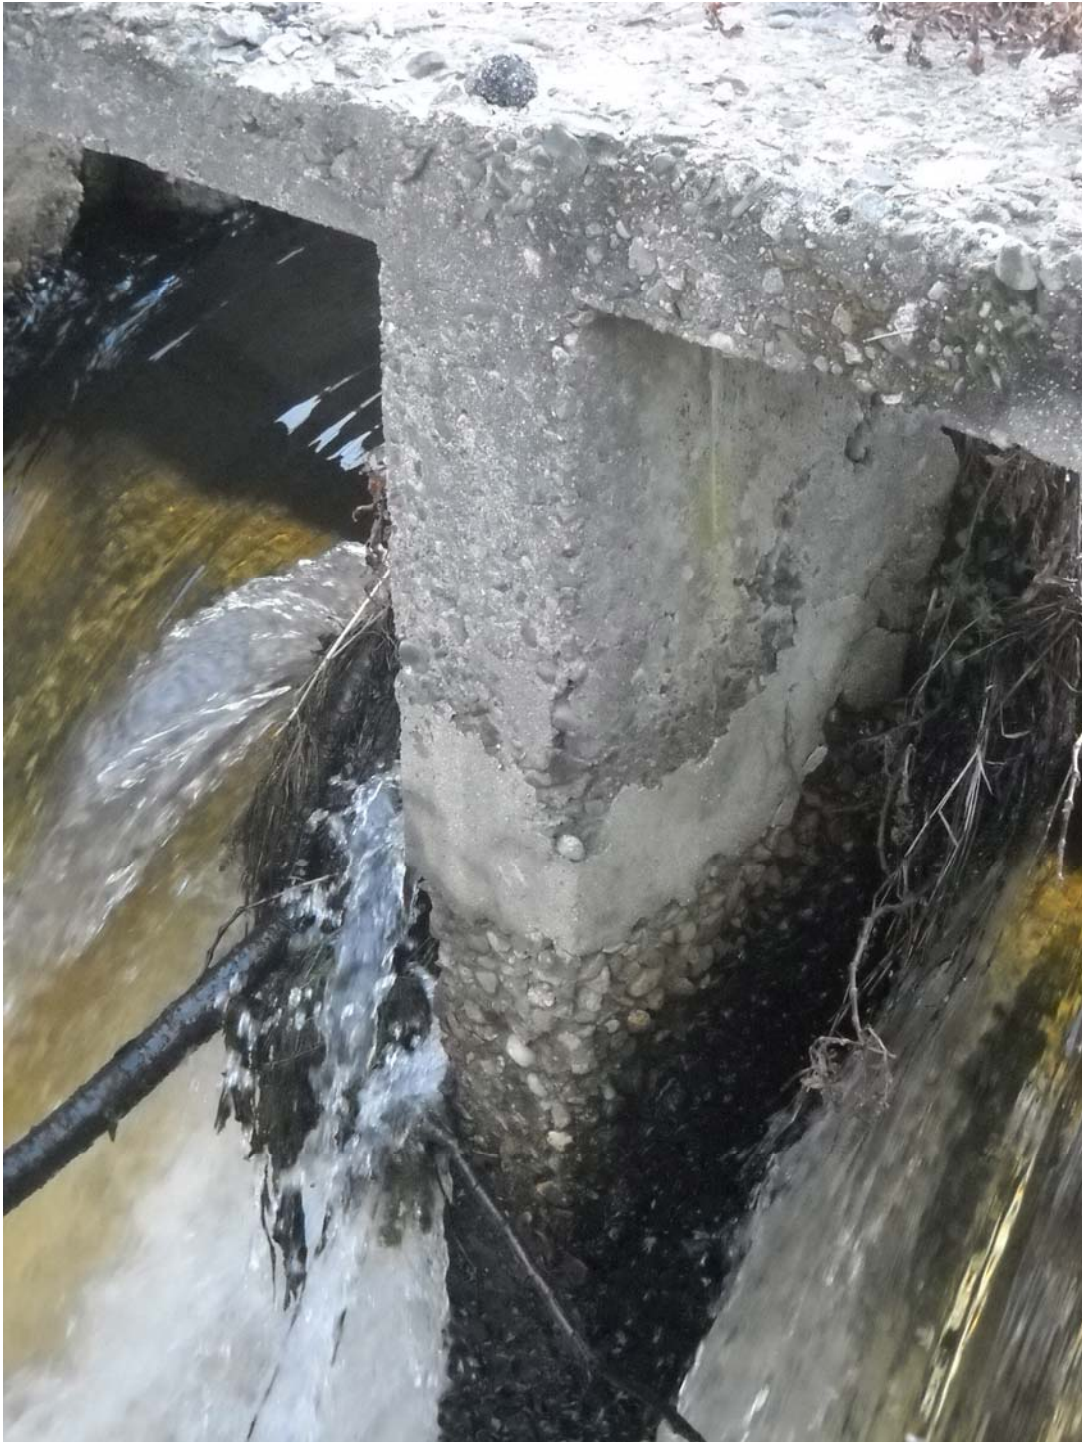
Photo 21F – Exposed aggregate and deteriorated concrete at weir support column

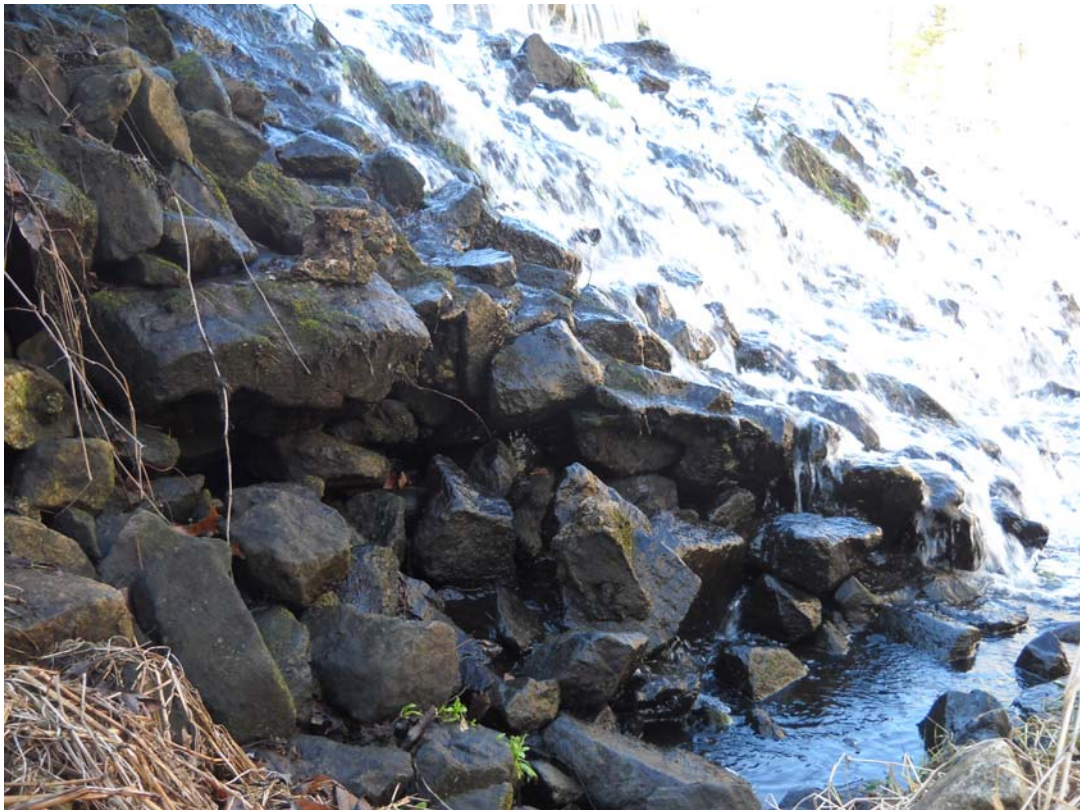
3. Riprap has dislodged from the downstream face of the auxiliary spillway at its right embankment contact.
 4. The upstream slope of the left embankment has significant erosion resulting in vertical and undercut areas. The vertical fieldstone masonry wall along the downstream face has collapsed in a couple of locations causing erosion of the downstream slope and sinkholes in the crest.

Photo 21G – Area of missing/fallen riprap at right auxiliary spillway contact

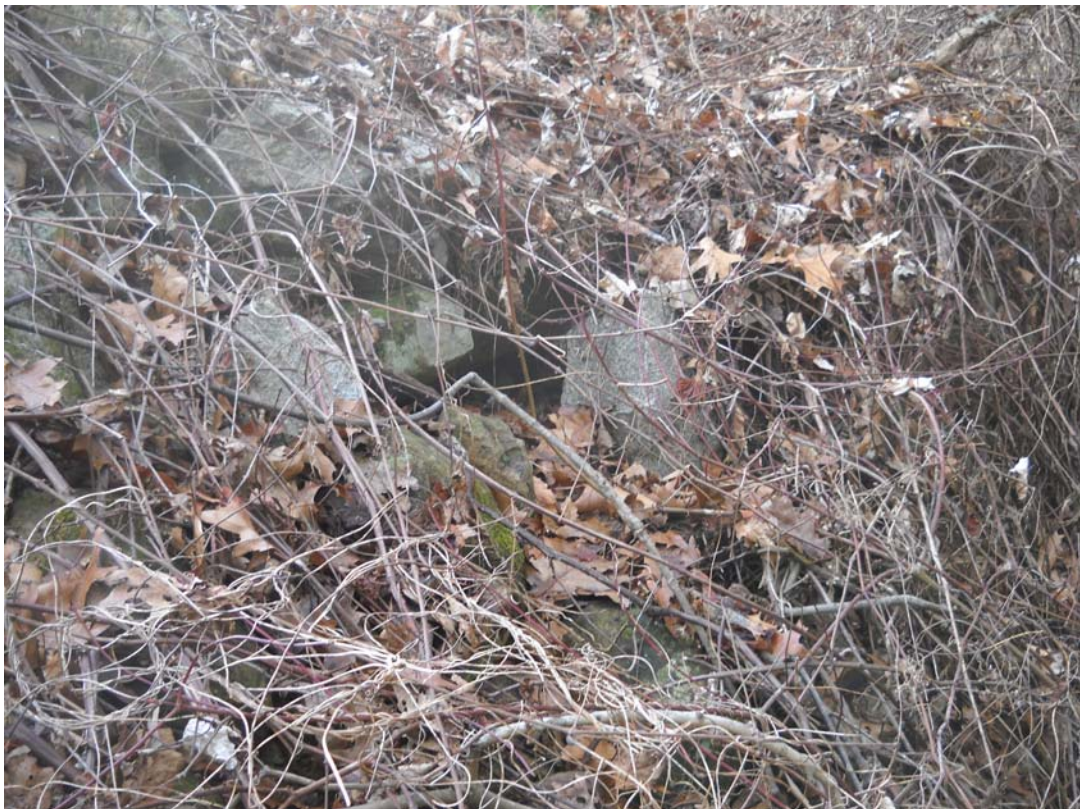
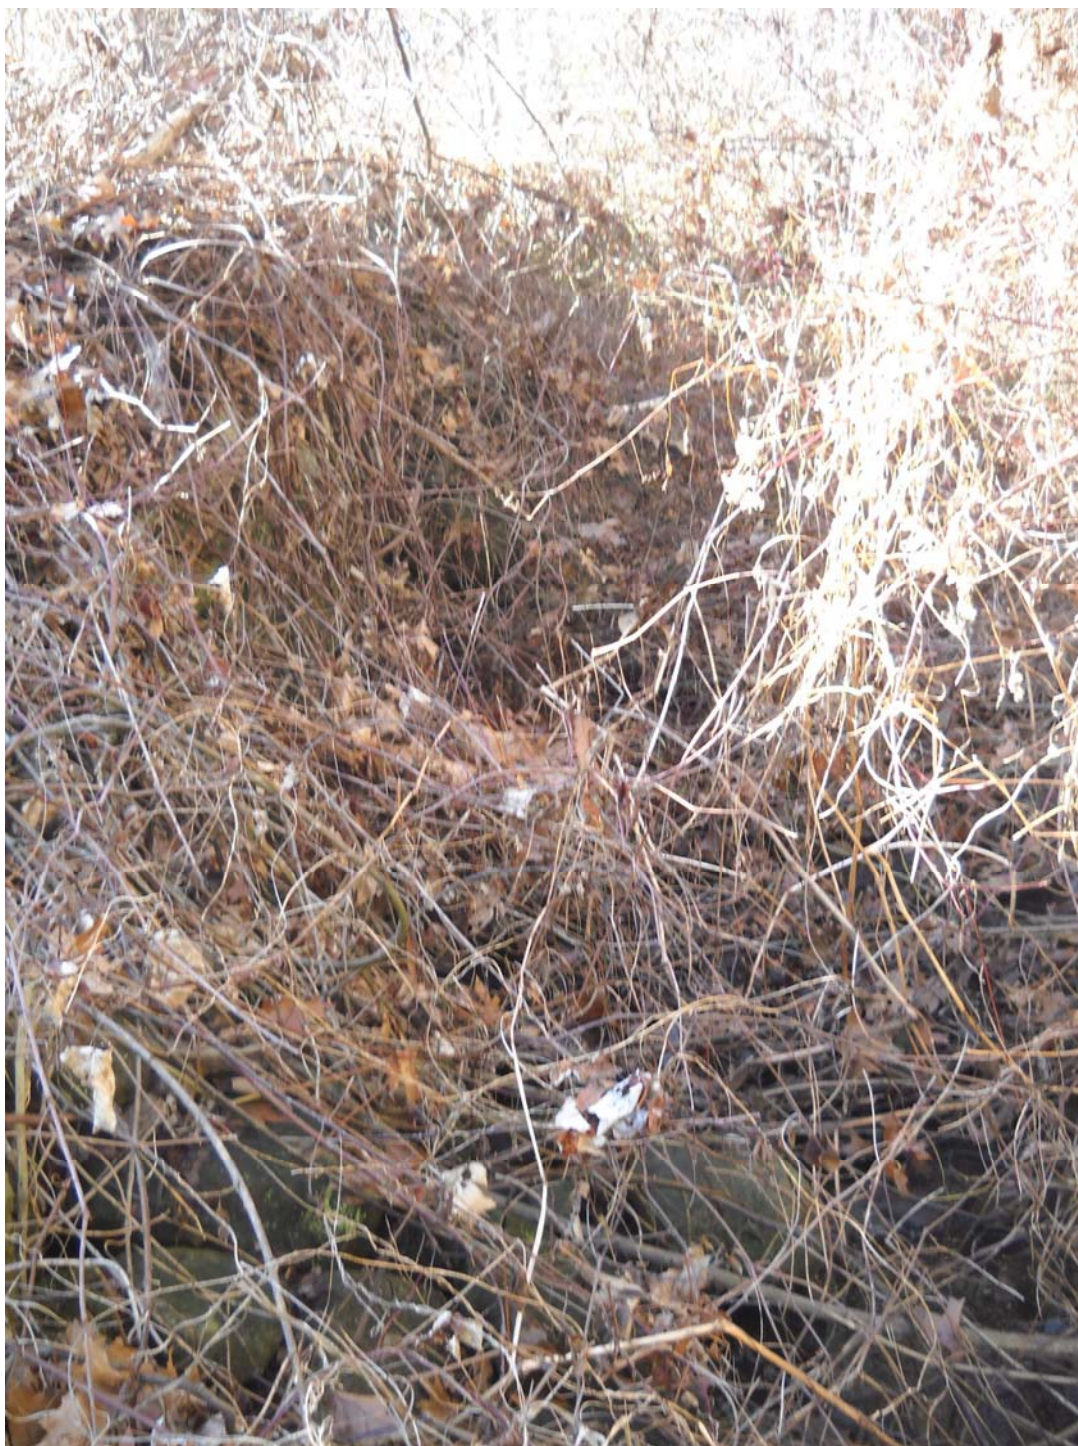
- **Downstream Face** of the embankment left of the auxiliary spillway is a vertical dry-set fieldstone retaining wall in poor condition. Heavy brush and tree growth obscures much of the face. There were two areas of the wall which have partially collapsed causing erosion of the face and crest above the wall in those locations. Other areas of

the wall appear to be bulged and out of alignment. It appears that roots from large trees adjacent to the toe of the wall may be contributing to movement in the wall. There was no seepage observed through the wall but seepage was observed in some locations 5 to 10 feet from the toe of the wall.

Photo 21H – Collapsed vertical wall near auxiliary spillway

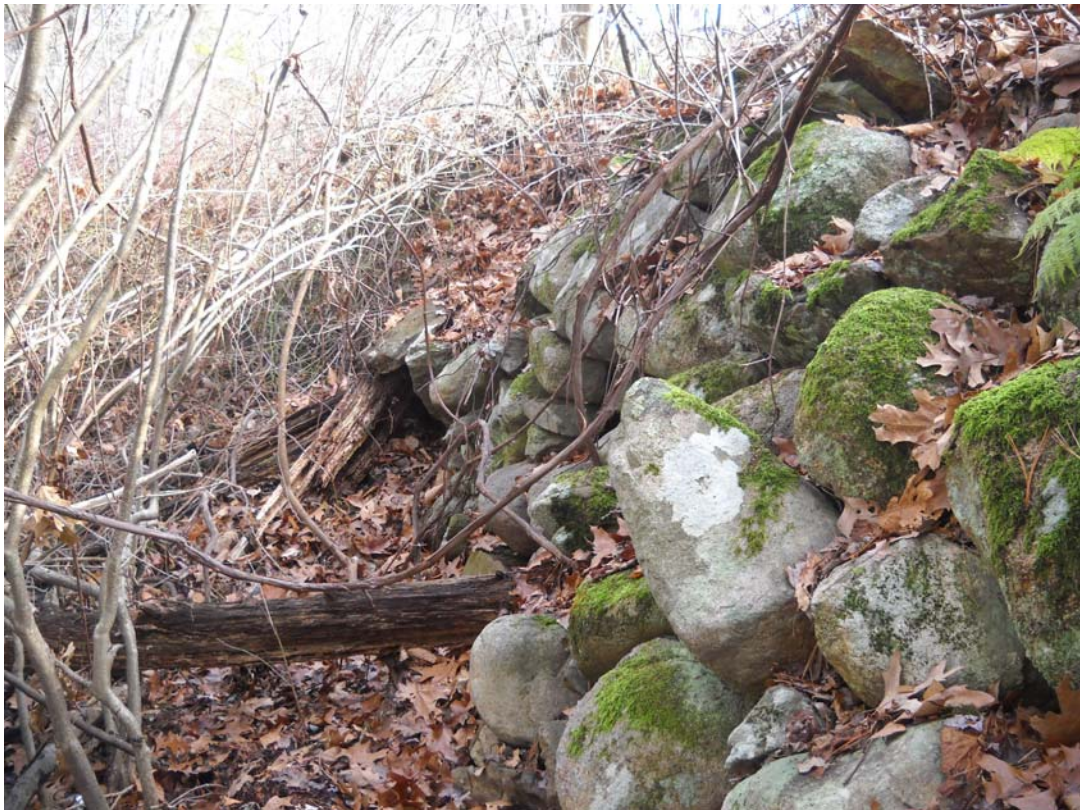
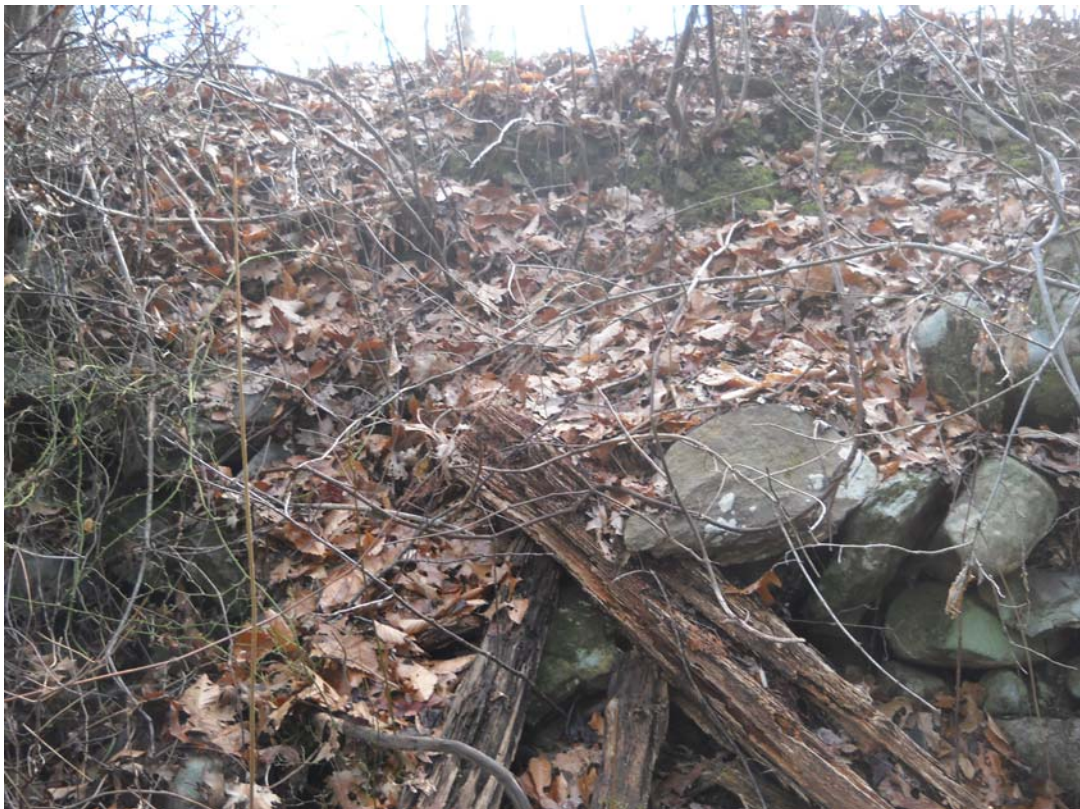
Photo 21J – Collapsed vertical wall approximately 50 feet from left abutment

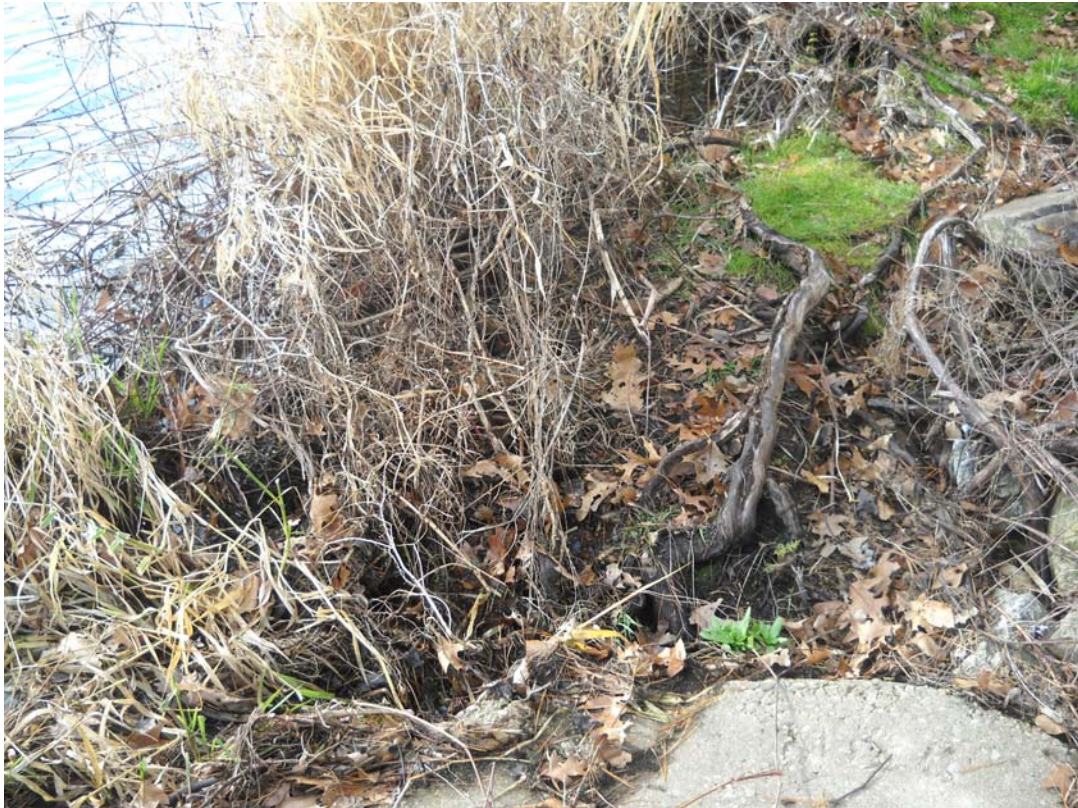
Photo 21L – Exposed roots, erosion and sinkholes upstream face and crest near left auxiliary spillway contact

- Amory Engineers recommends the following to address deficiencies:
 1. Remove all trees, brush and root systems from the embankment. Fill all voids with impervious fill material.

2. Fill sinkholes with impervious fill.
 3. Reconstruct the upstream slope of the left embankment to provide a consistent, sloped face. Armor the slope with riprap stone.

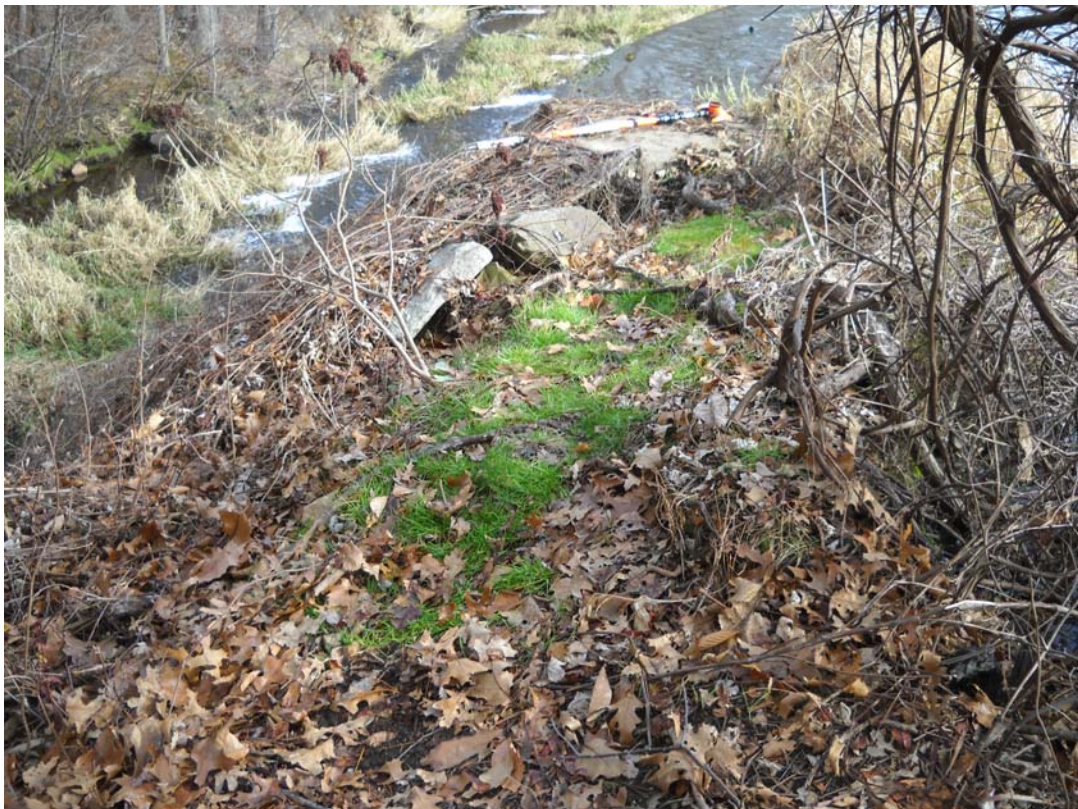
Photo 21M – Exposed roots and sinkholes downstream face and crest near left auxiliary spillway contact

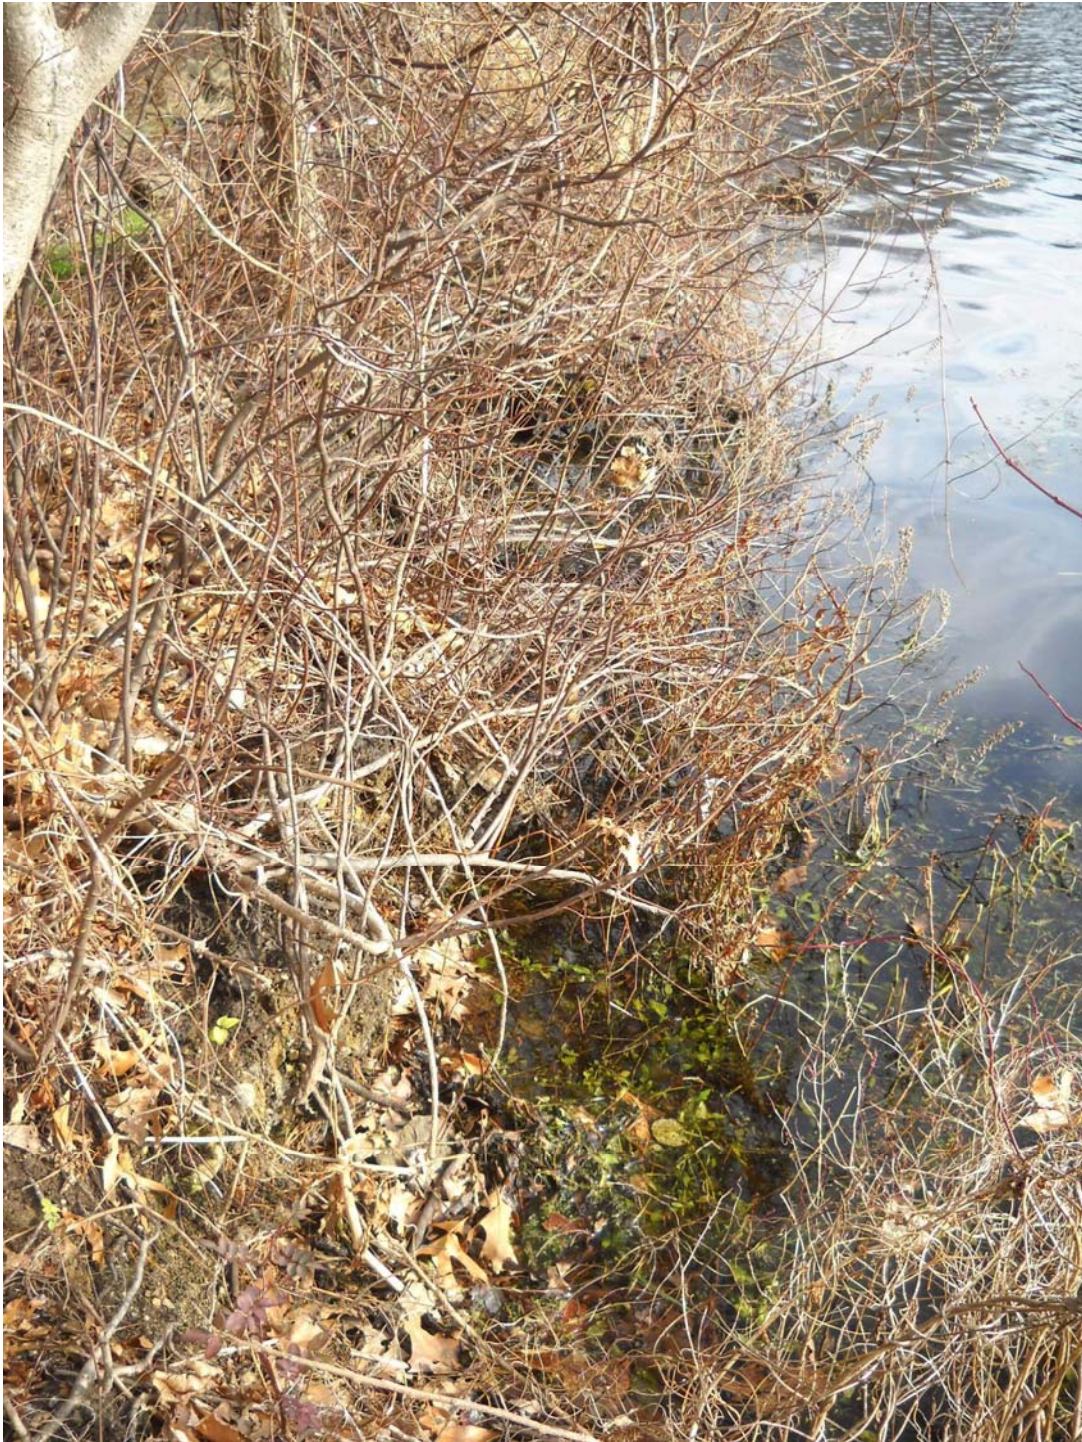
- **Abutments** are in fair condition.
- **Upstream Face** is in poor condition along the embankment left of the auxiliary spillway. There is severe erosion which has left the face vertical and undercut in some areas. There is no sign of riprap slope protection.

Photo 21N – Eroded upstream face left of the auxiliary spillway

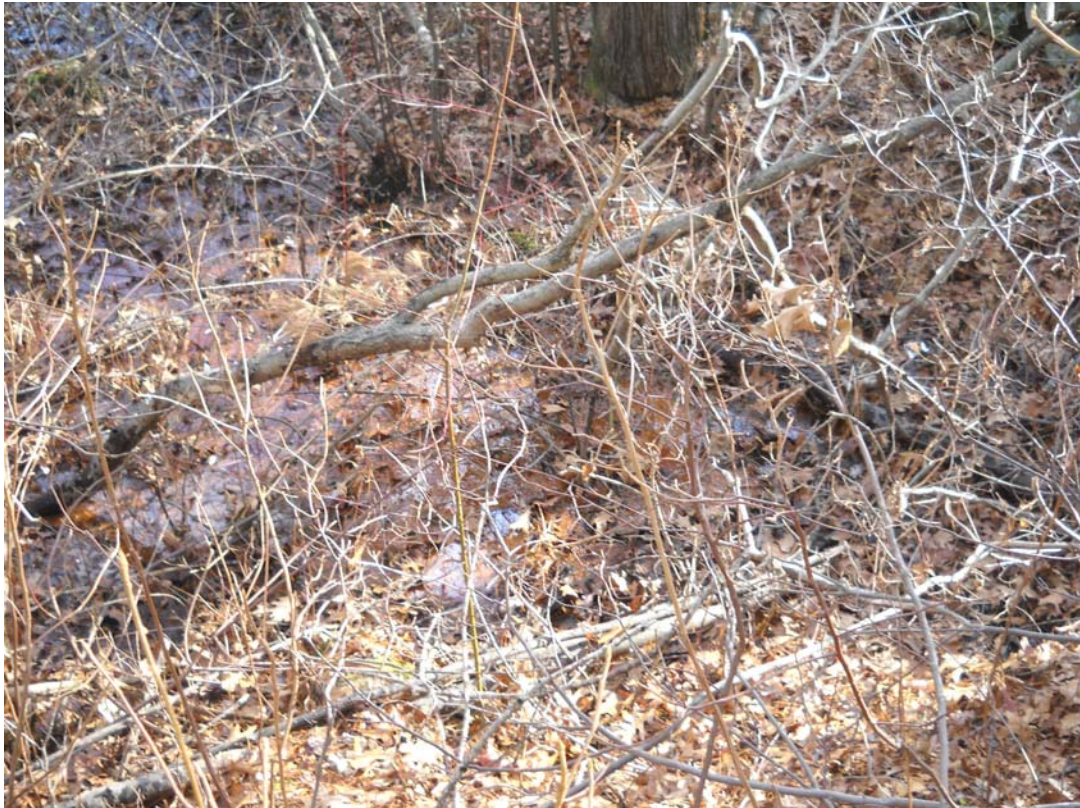
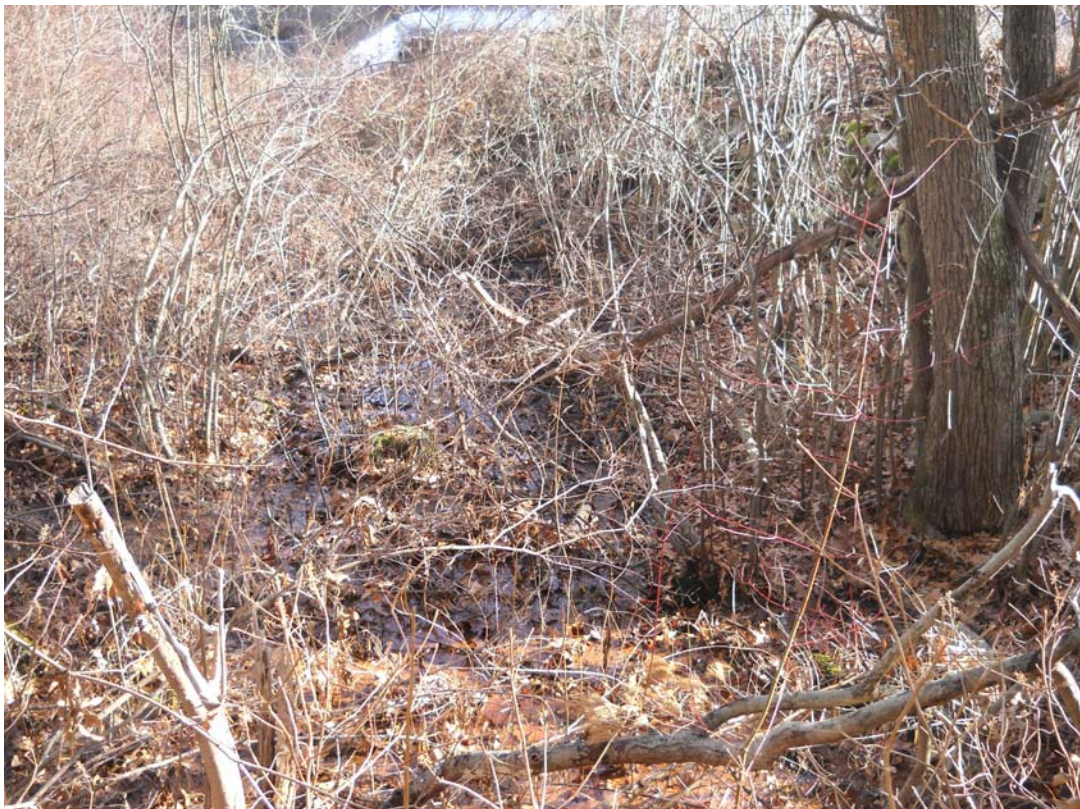
Seepage was observed at a number of locations five to ten feet downstream of the left embankment. The seepage does not appear to be significant but should be monitored. Because of the discharge channel along the toe of the auxiliary spillway, primary spillway and the embankment between the spillways, seepage at these locations could not be determined.

Photo 21O – Seepage downstream of left embankment

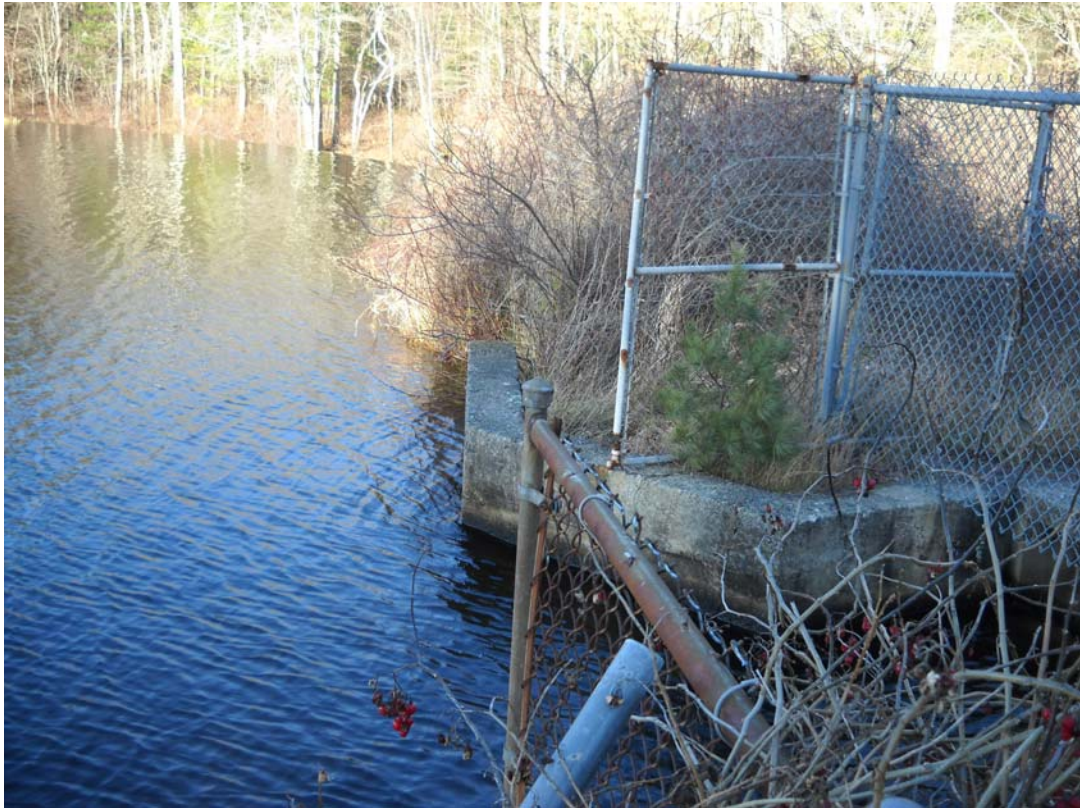
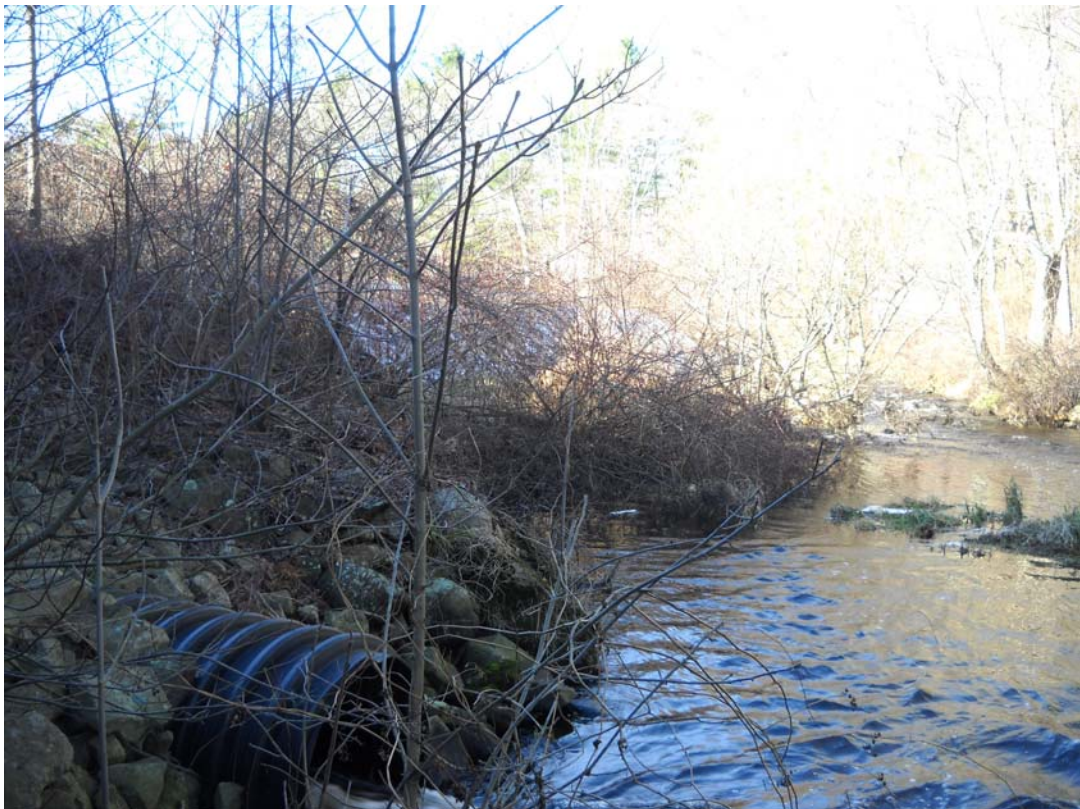
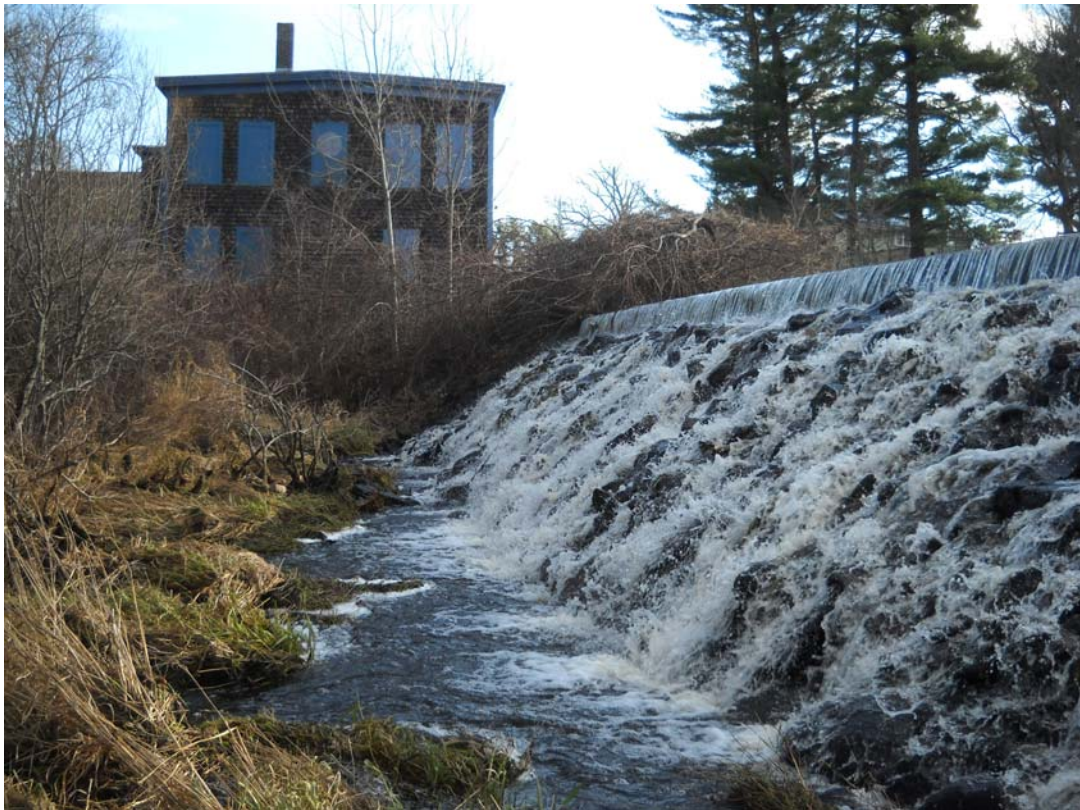
The embankment crest between the spillways is in fair condition. The crest in this area is about 20 to 25 feet wide but it is overgrown with brush. The ground surface under the brush appeared to be a boney gravel with no loam or grass vegetation. There were no signs of erosion.

Photo 21Q – Brush on embankment between spillways (from right abutment upstream)

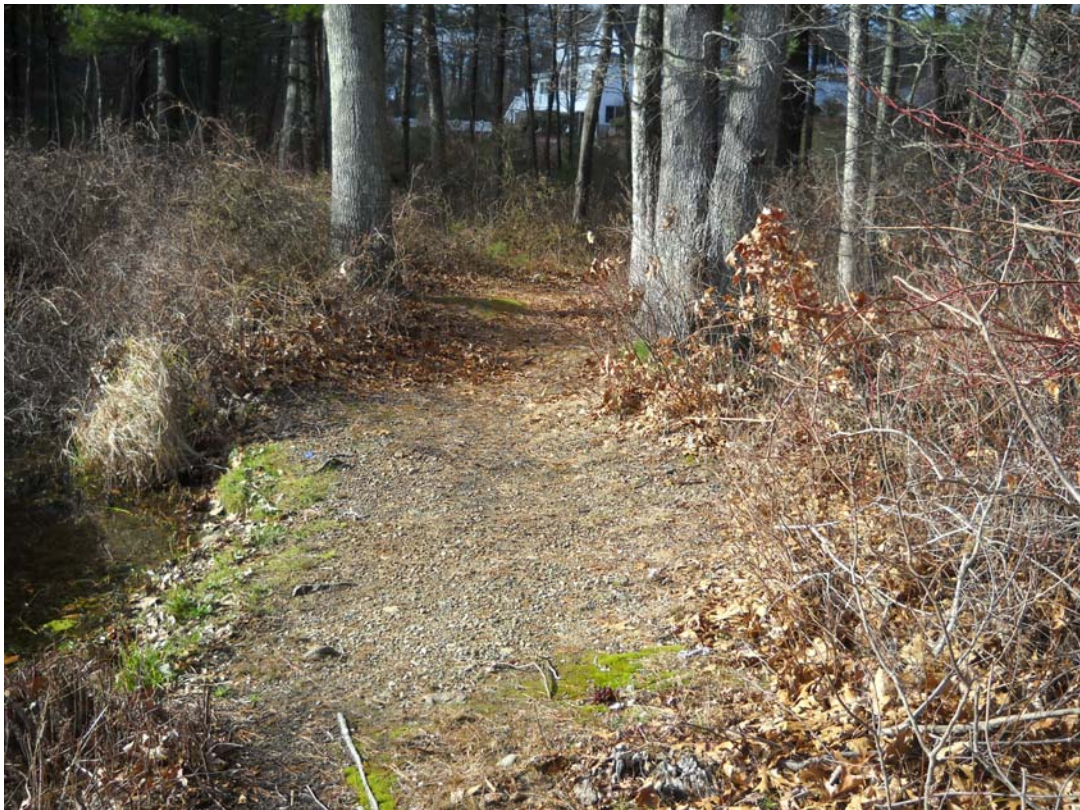
- **Crest** of the embankment left of the auxiliary spillway is in poor condition. The width of the crest is fairly narrow due to 1) erosion along the upstream face and 2) erosion due to collapse of the fieldstone retaining wall in a couple of locations along the downstream face. Trees, brush and exposed roots are present on the crest as are sink holes due to the erosion. The crest is not level due to a worn walking path and erosion. There are three large trees on the crest near the left abutment (>24-in. diameter).

Photo 21U – Large trees on crest near left abutment

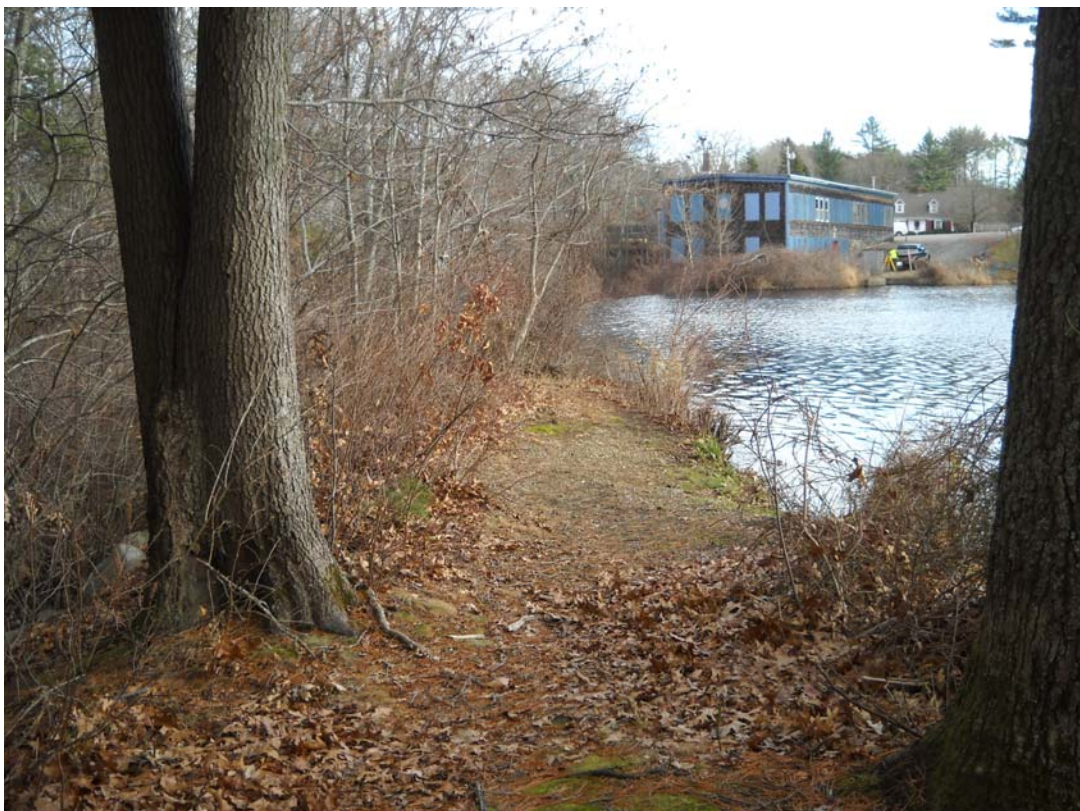
Photo 21V – Trees and brush on left embankment (from left abutment)

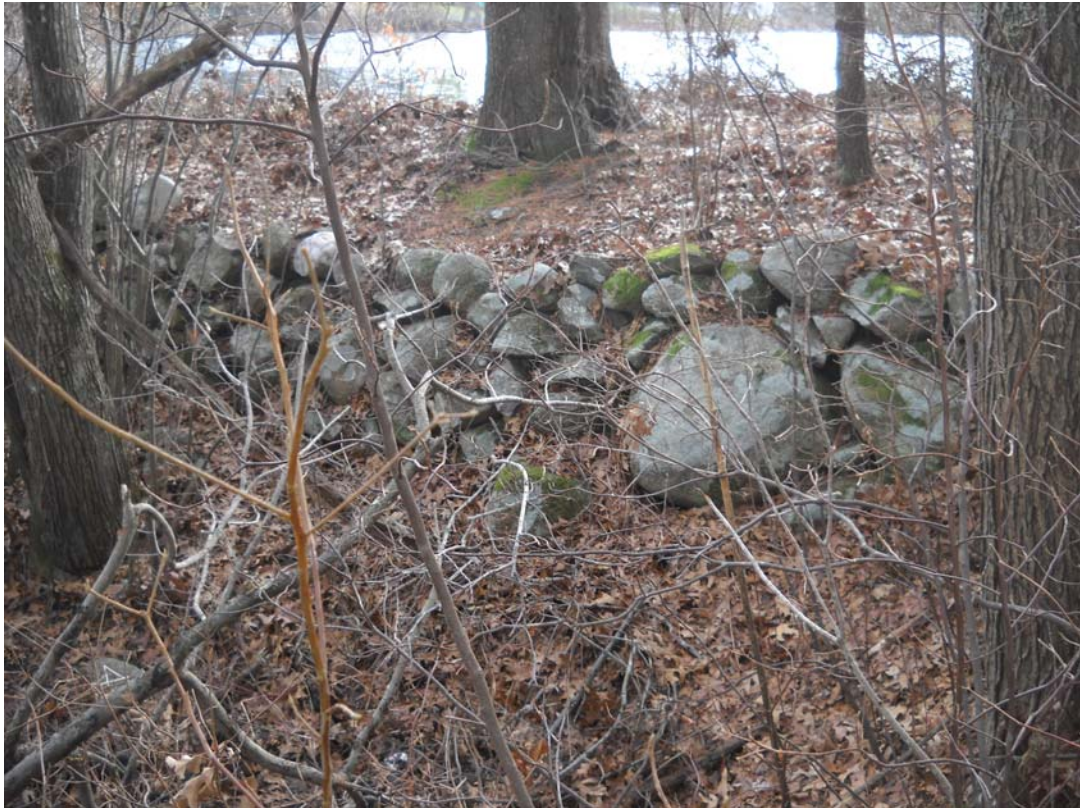
Photo 21W – Trees on crest of left embankment and adjacent to downstream vertical fieldstone masonry wall
