How Feasibility Analyses are Used to Develop a Preferred Resiliency Project Alternative:

Examples from Crescent Beach Revetment Rehabilitation (Hull) and North Scituate Beach Nourishment

John S. Ramsey, P.E.

Applied Coastal Research and Engineering, Inc.

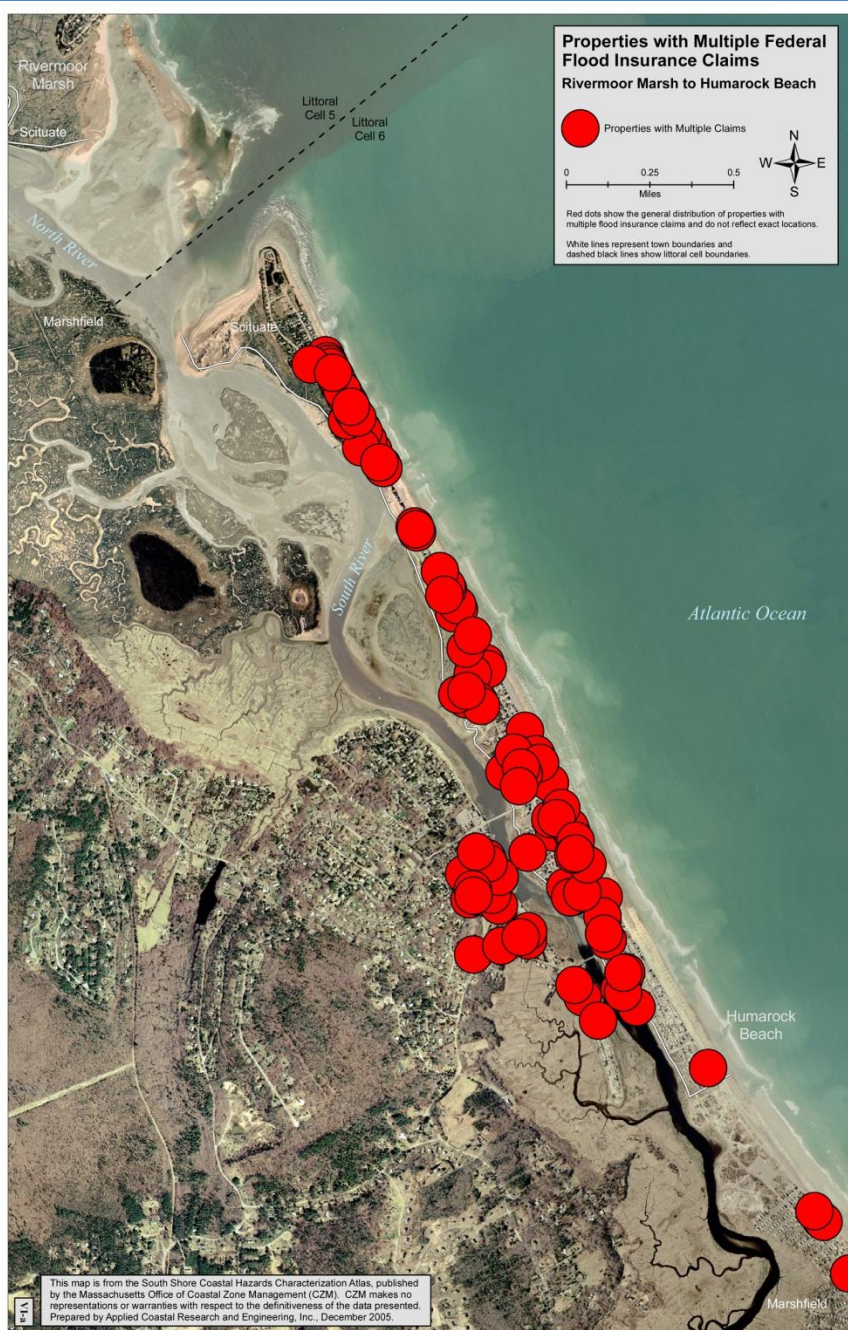
Properties with Multiple Flood Insurance Claims

High Storm Susceptibility Leads to More Frequent Flood Damage

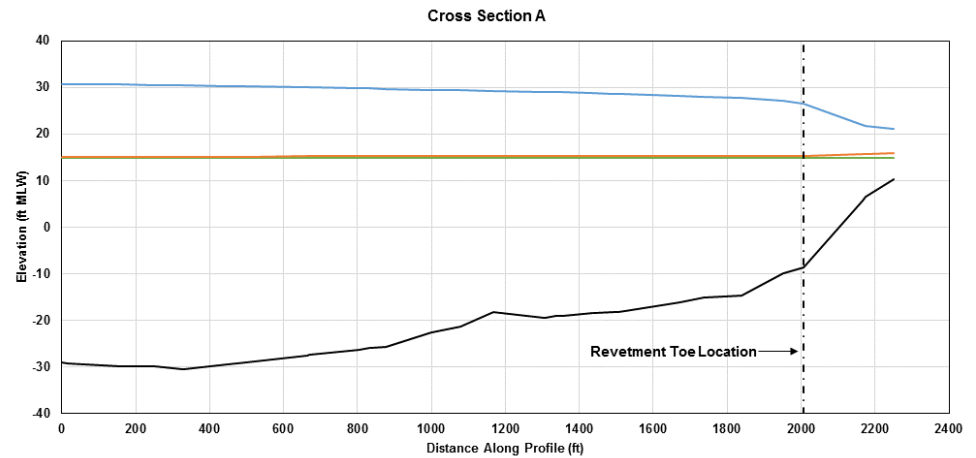
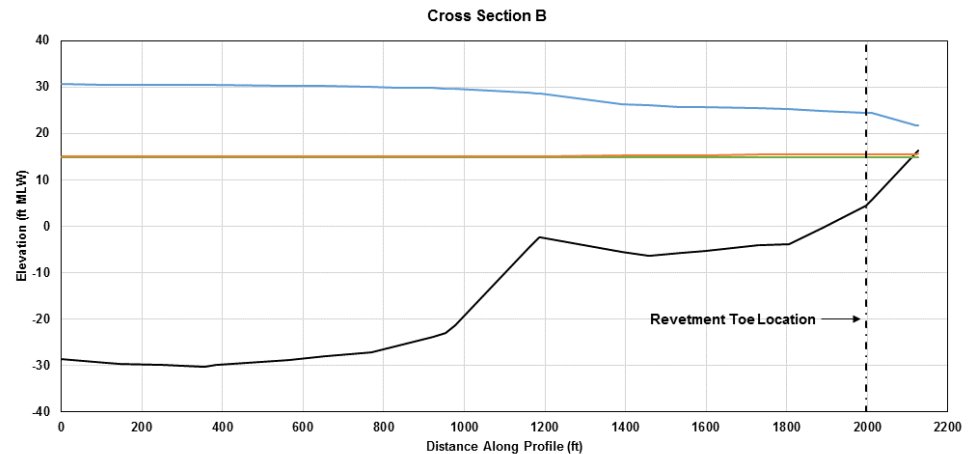
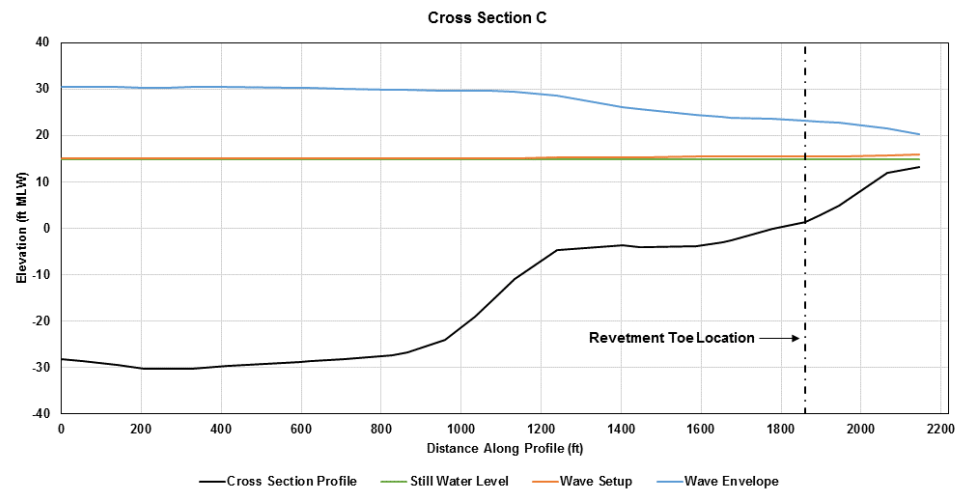
Existing Conditions

- Breakwater is under-resolved with 164 ft grid spacing (Cross Section B and C)

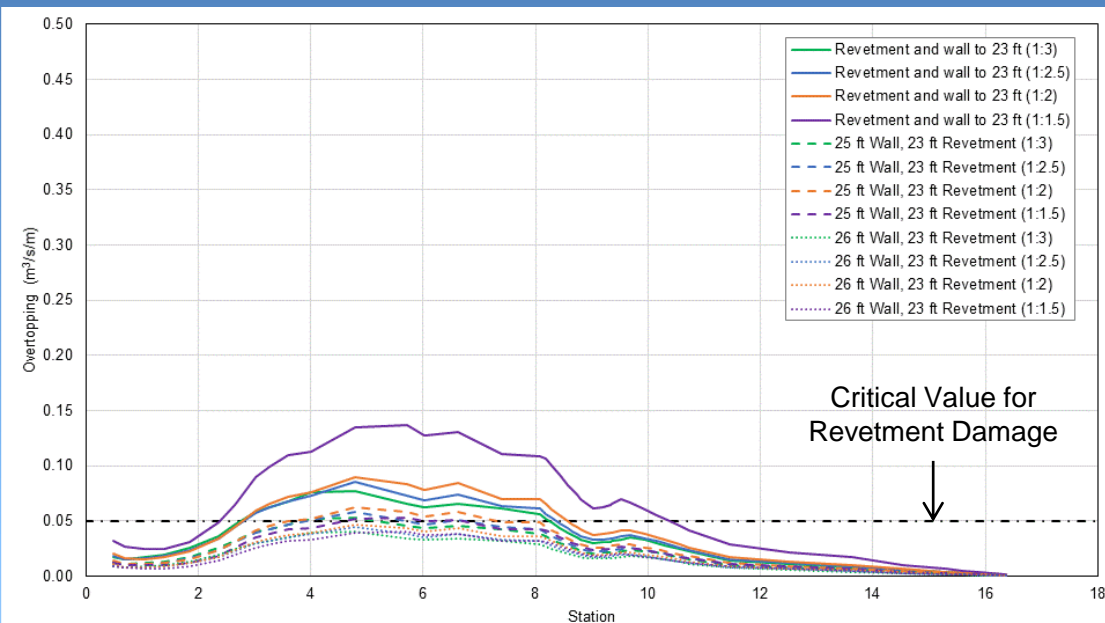
23 ft MLW Revetment

- Overtopping estimated by Pedersen (1996)

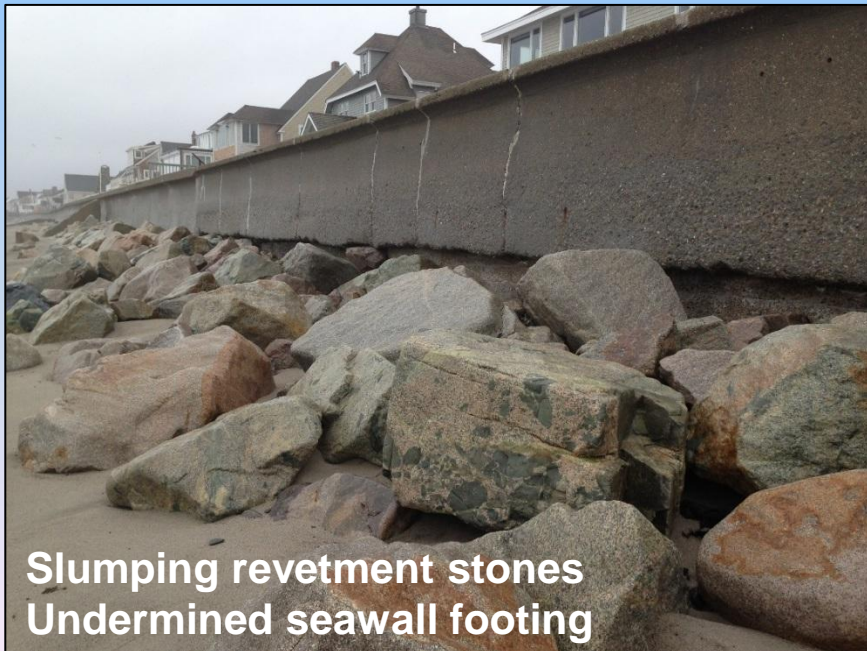
- 2007 South Shore Coastal Infrastructure Inventory found that the majority of the seawall and revetment is in Fair condition with evidence of wall cracking and spalling, loose and/or slumping stones, and undermined seawall footings at several locations
- Water marks on stones indicate that much of the revetment is below water at high tide
- While submerged, the revetment does not efficiently dissipate wave energy, therefore the seawall is the primary means of shore protection during storms

**Slumping revetment stones
Undermined seawall footing**

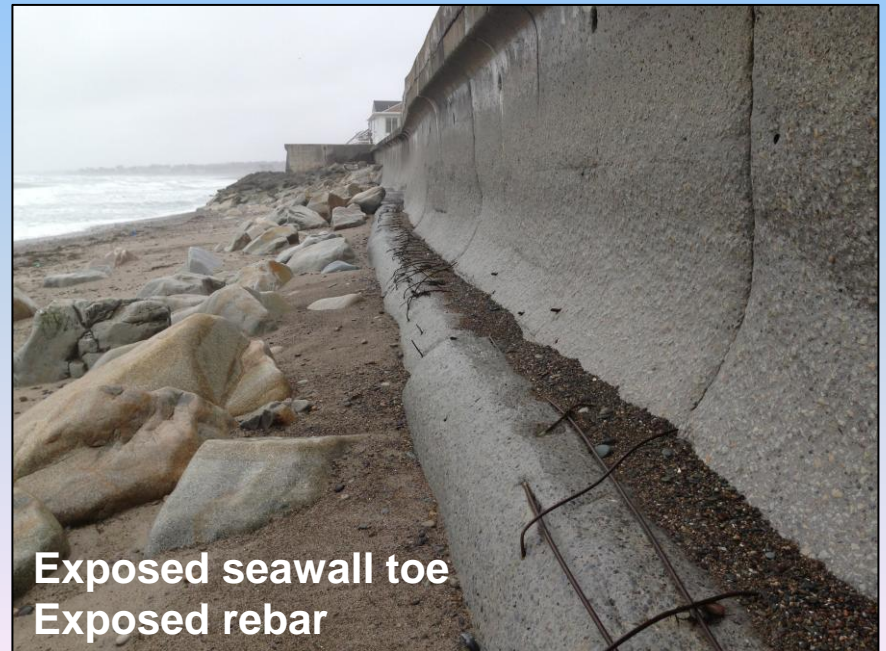
**Exposed seawall toe
Exposed rebar**

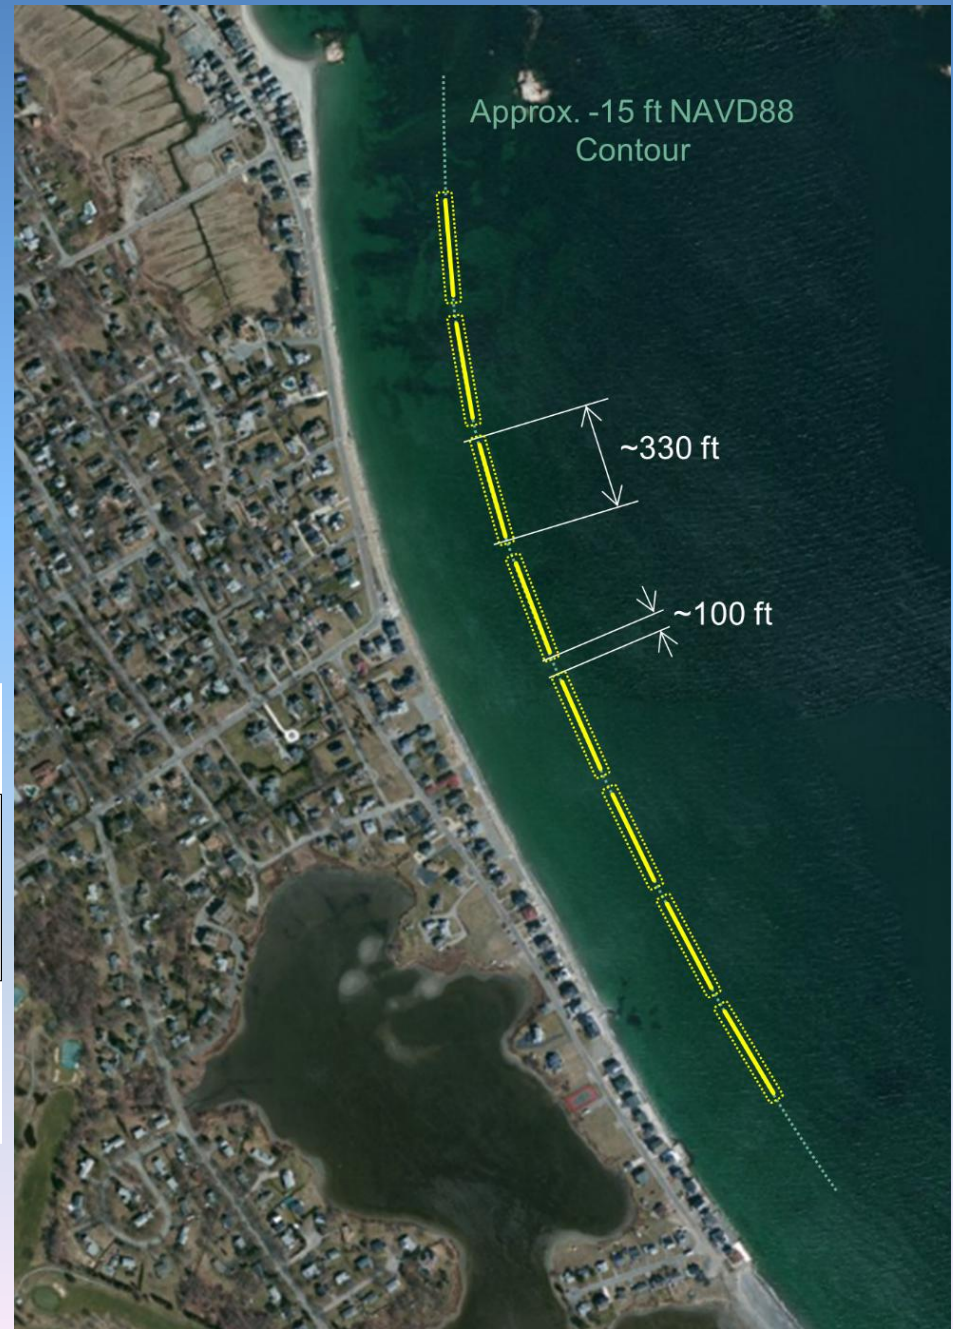
Nearshore Breakwater

Preliminary design:

- Approx. 3,300 ft total length
- Approx. 400 ft offshore
- Crest elevation of 13.5 ft NAVD88 (emerged during entire tide cycle)
- Total stone volume of 133,000 CY
- Footprint of 6.3 acres
- Approx. cost: \$23,000,000

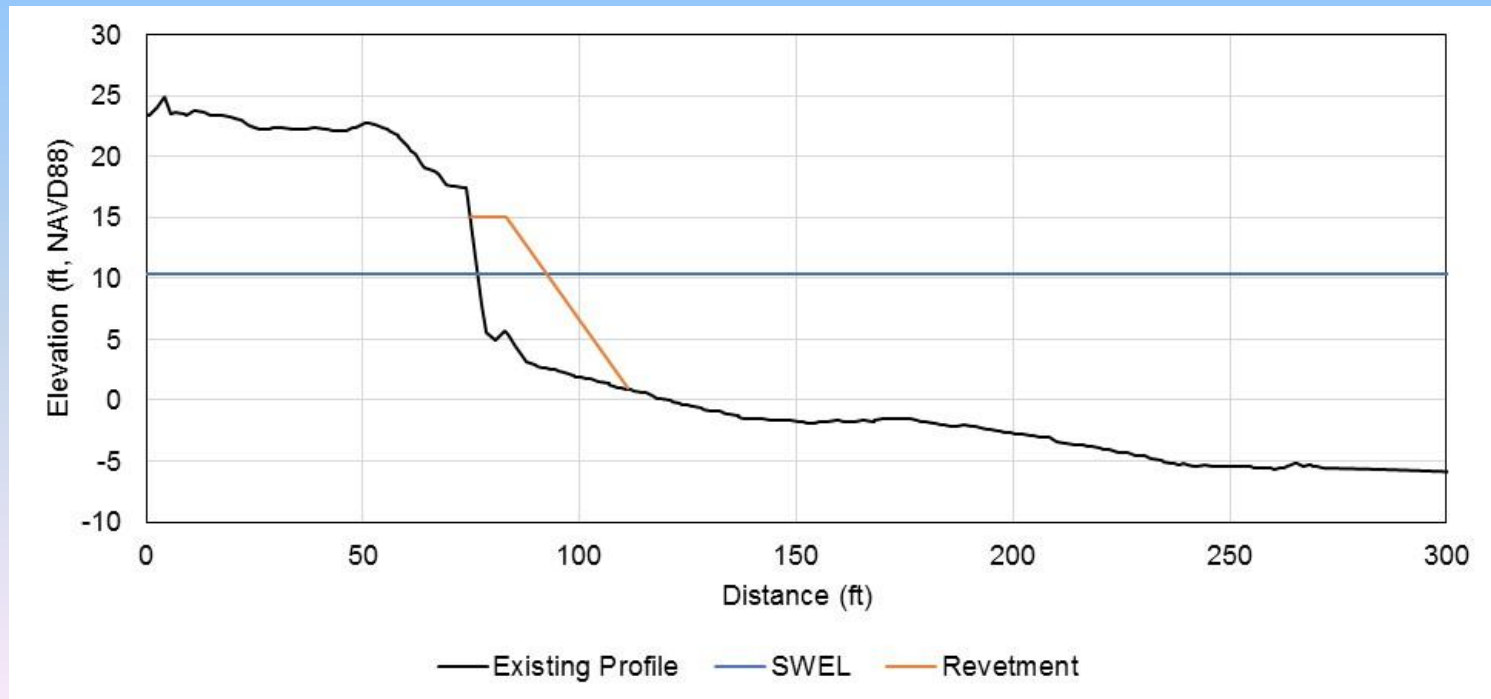
Repair Seawall and Rebuild Revetment

Preliminary revetment design for 100-year storm:

- 15 ft NAVD88 revetment crest
- 1V:2H slope
- Designed toe extends ~40 ft from wall
- Approx. 60% overtopping reduction
- 113,000 CY of armor stone required
- Footprint approximately 4.2 acres
- Approximate cost: \$32,000,000

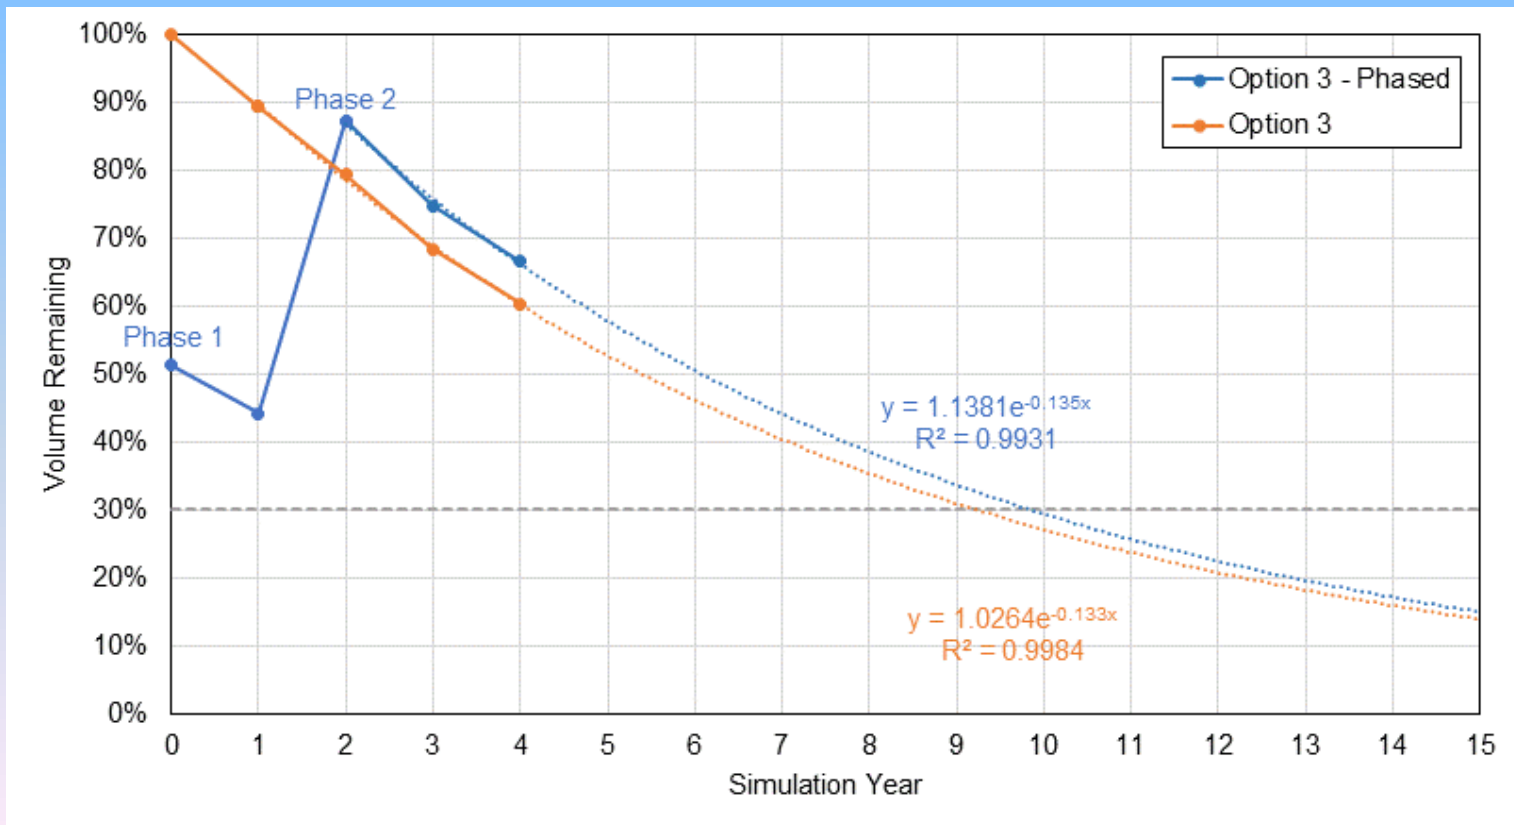
Phasing – Option 3

- 50% of fill volume placed along southern half of wall (Station 14+00 to 29+00) at Year 0
- 50% of fill volume placed along northern half of wall (Station 3+00 to 14+00) at Year 2

Nourishment Option	Design Life (years)
3 (100 ft berm)	9
3 – phased (100 ft berm)	10
