Building Coastal Resiliency at Plymouth Long Beach

Department of Marine and Environmental Affairs

December 1, 2016

Plymouth Long Beach & Warren's Cove

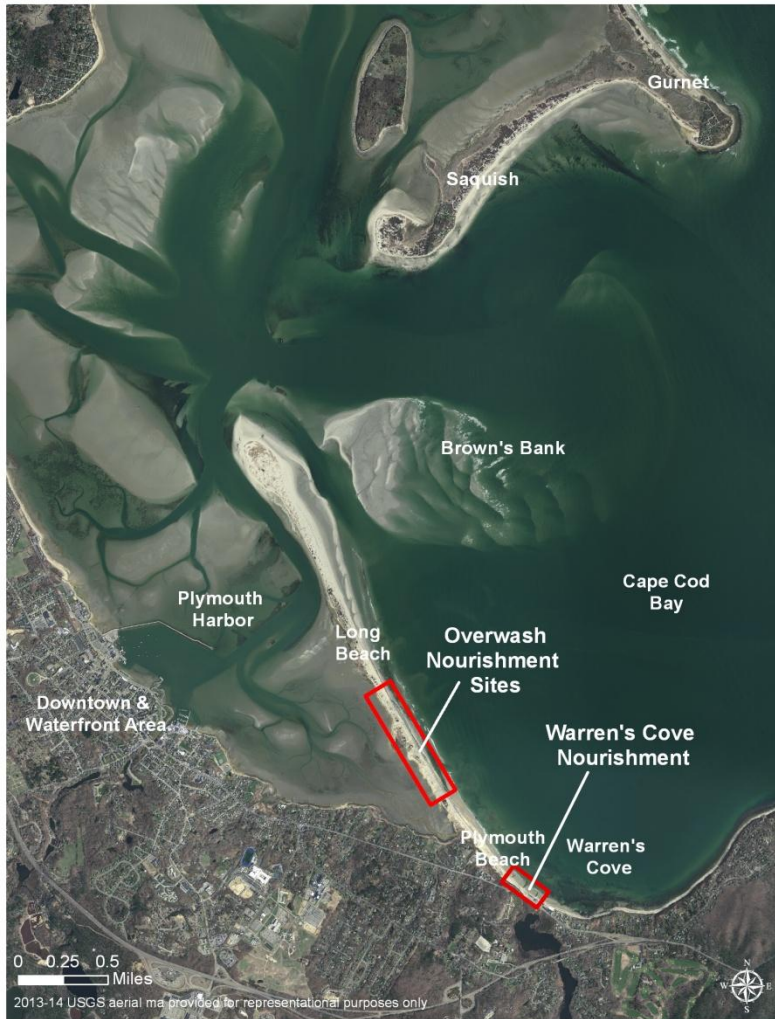
- Barrier spit 3 miles long, begins at Warren's Cove & forms Plymouth Harbor
- Shoreline management dates back to 1700's
- Seawalls and revetments at Warren's Cove
- Stone Dike runs the length of Long Beach (ACE)
- Northern part of beach protected from the east & northeast by Brown's Bank and Gurnet/Saquish

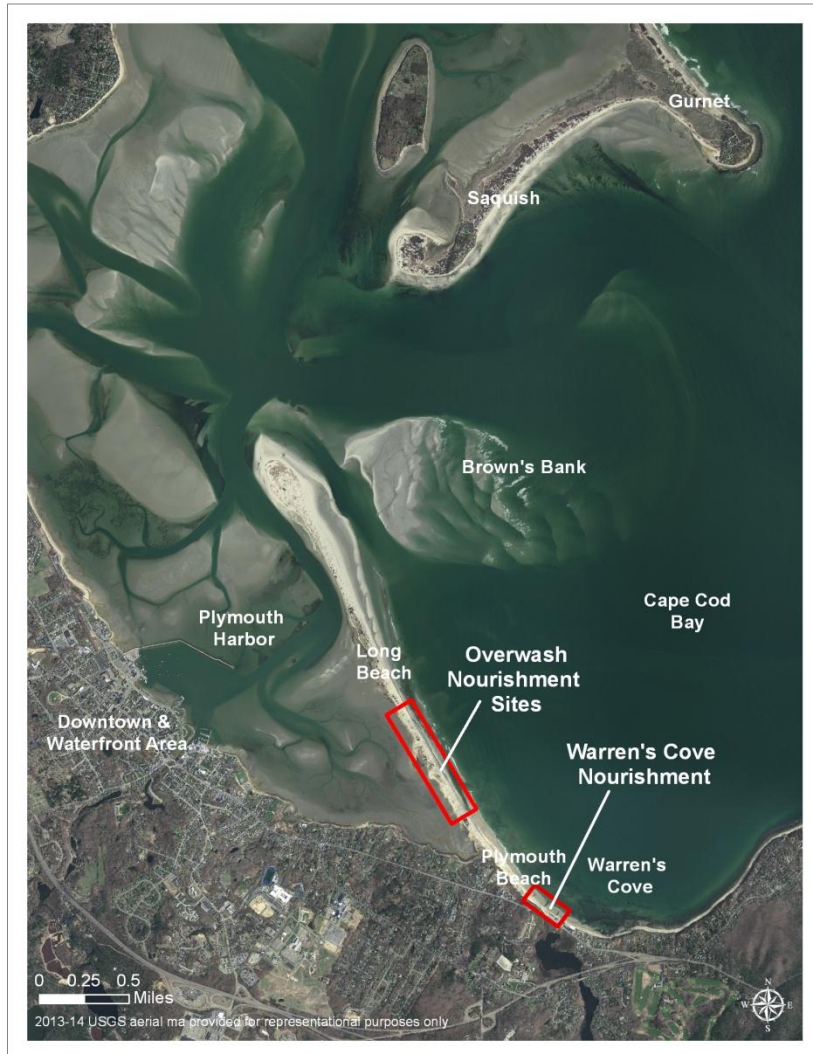
- Deterioration of middle portion of stone dike
- Lack of beach in the southern portion of Long Beach due to scouring along stone dike
- Eroded overwash areas on southern portion of Long Beach
- Erosion of harborside area along navigation channel

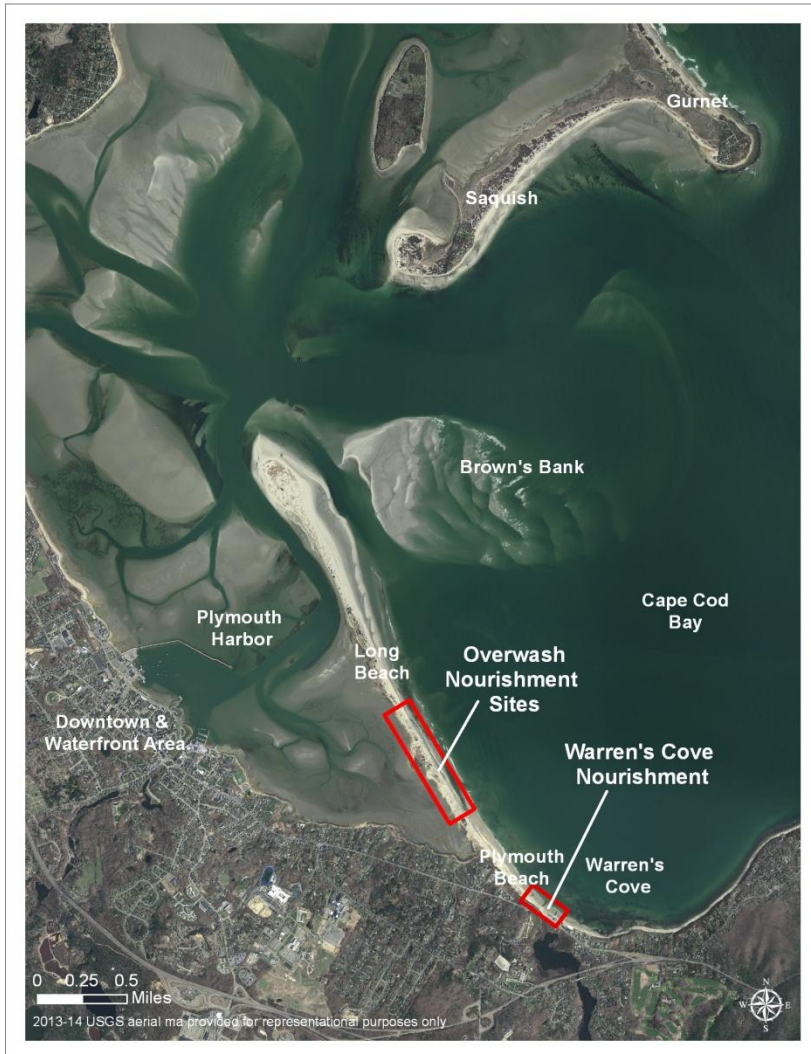
- Lack of beach at Warren's Cove due to scour from seawall/revetment
- Seawall failures
- Artificial and natural armoring of coastline to the south

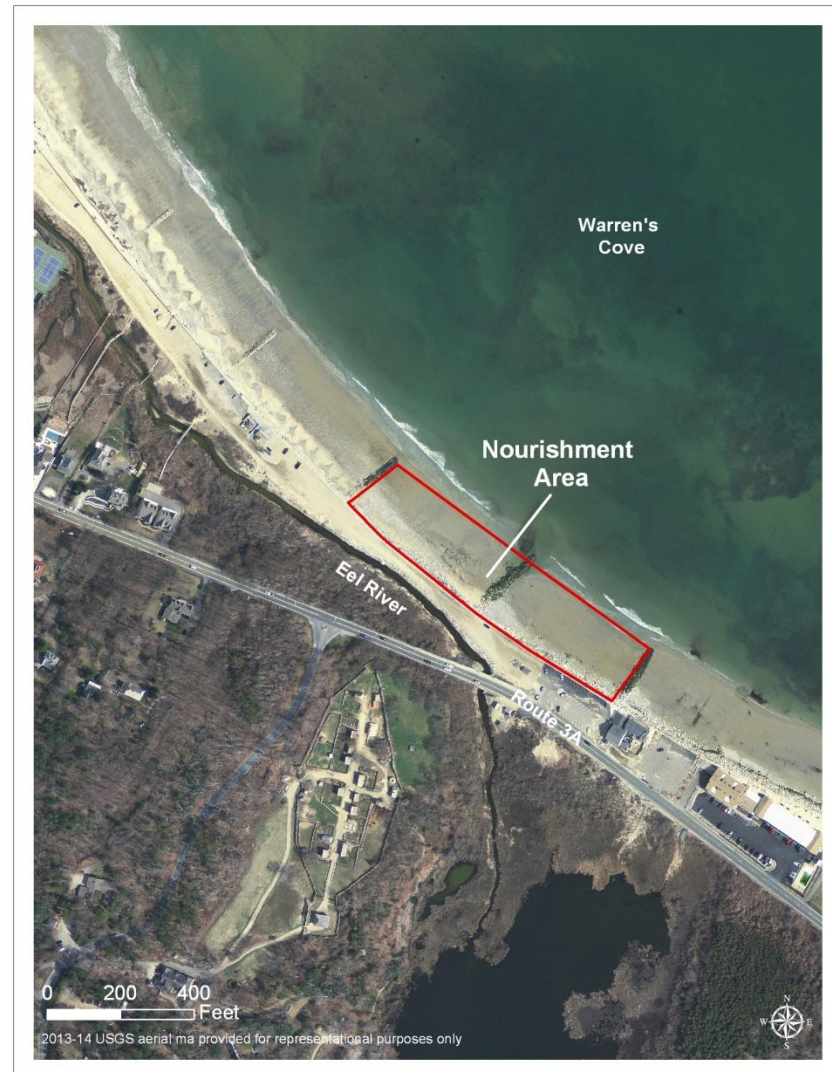
- Shoreline armored by seawall and revetment
- Five non-functioning groins
- Damage to Town beach facilities, Eel River, private properties and businesses, Route 3A, and utilities

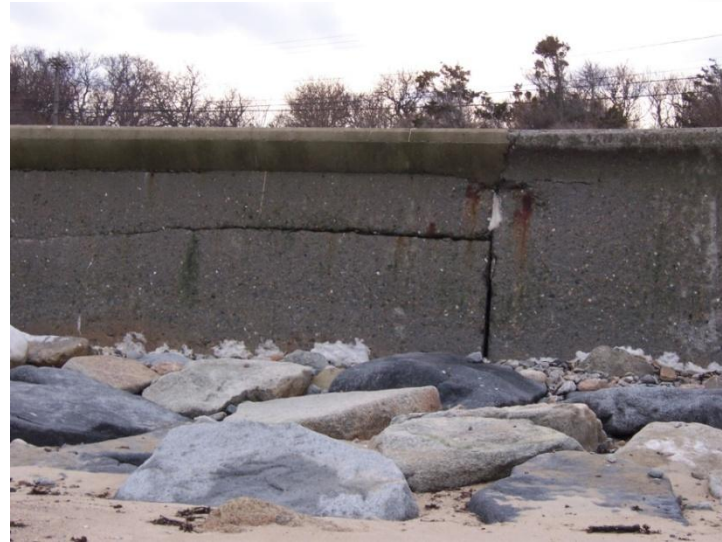
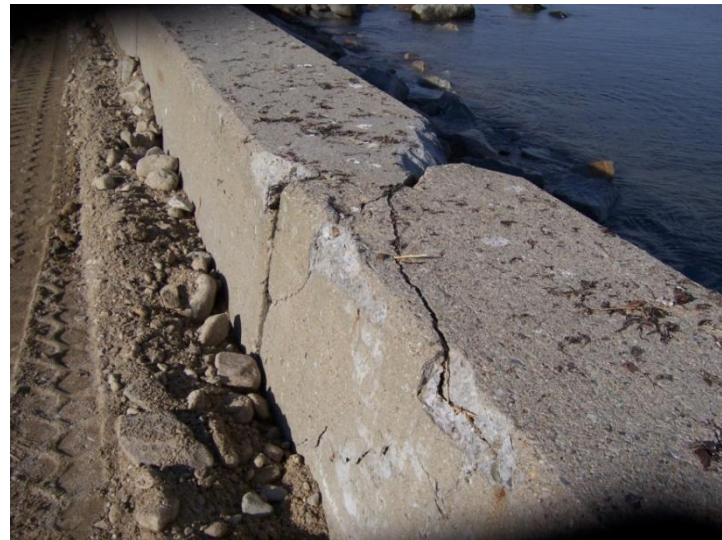
- Aging structure is compromised in multiple areas
- Undermining of seawall
- Seawall failures: 2010 and 2016

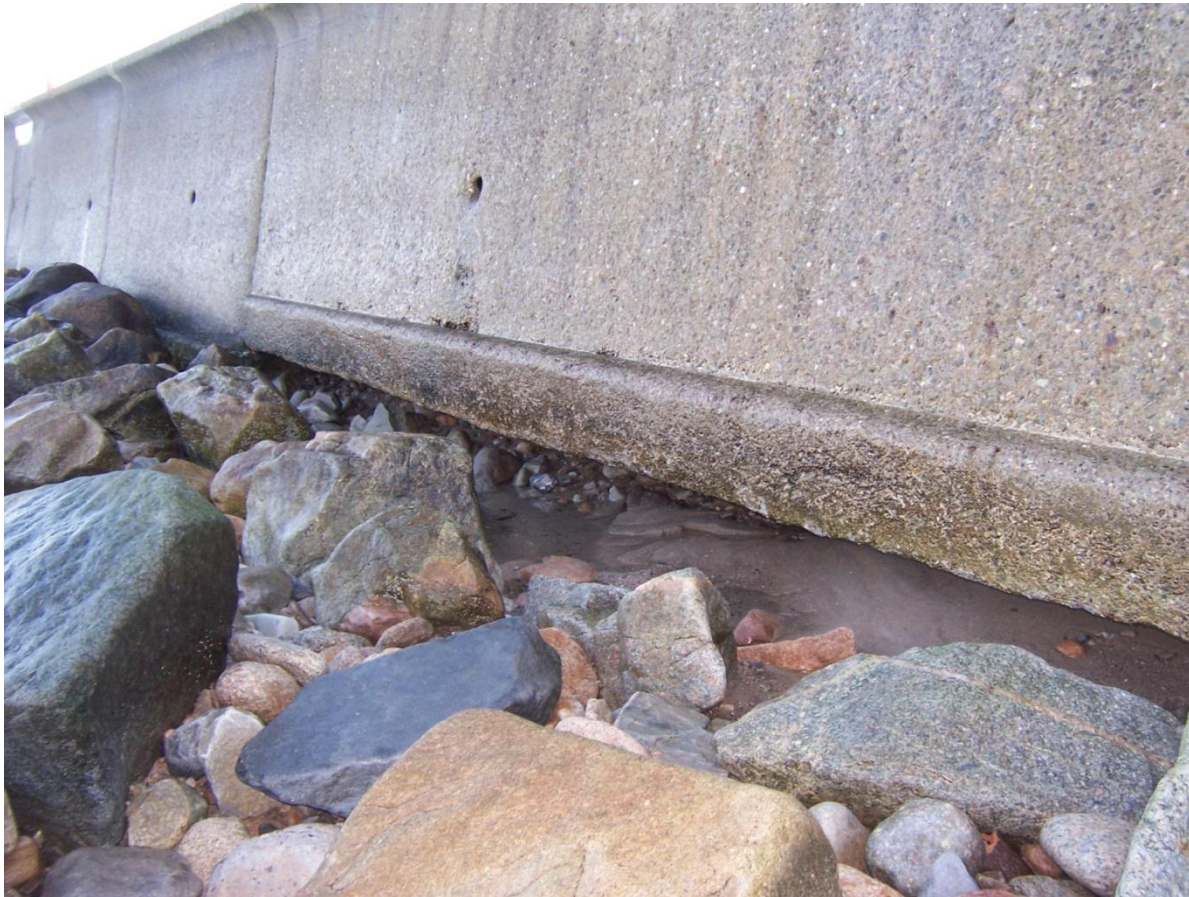
Undermining of Seawall (2009, 2010)

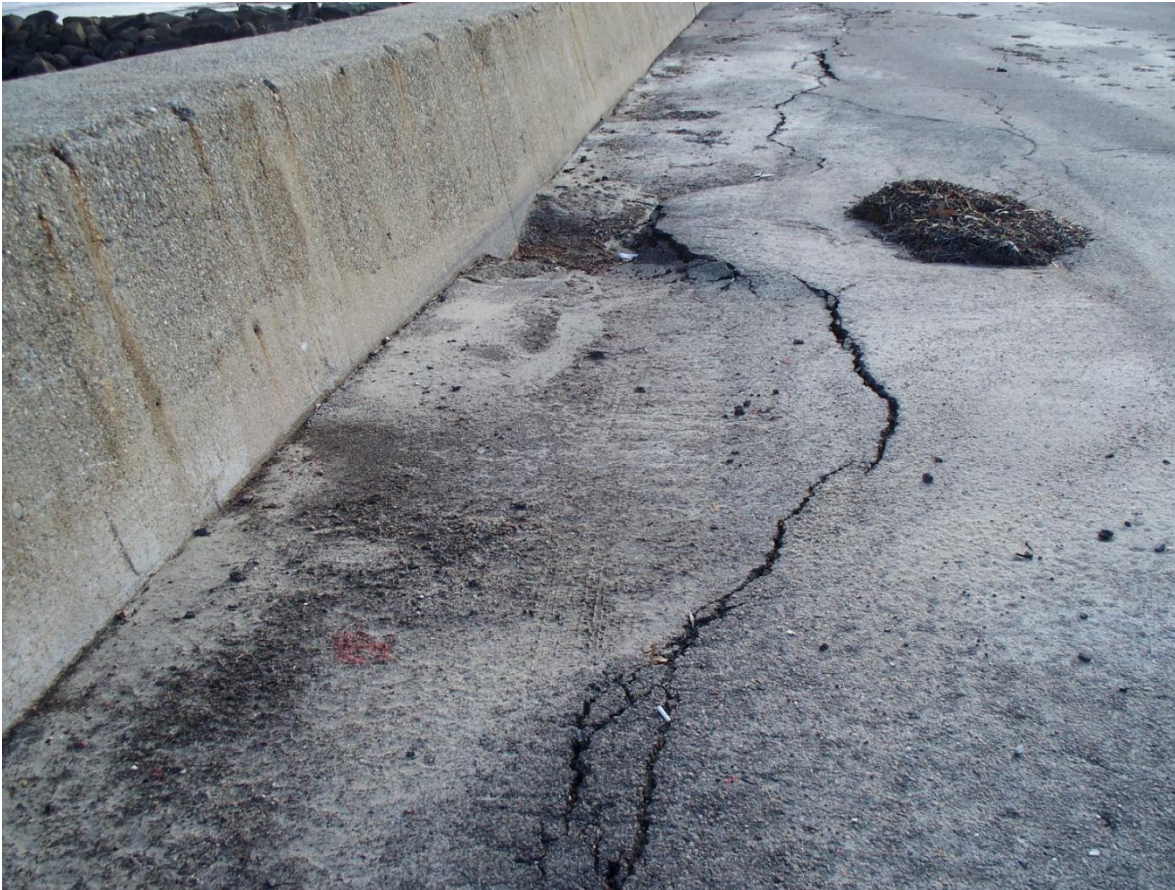
Collapse of Pavement Landward of Undermined Wall (Photo 12/09)

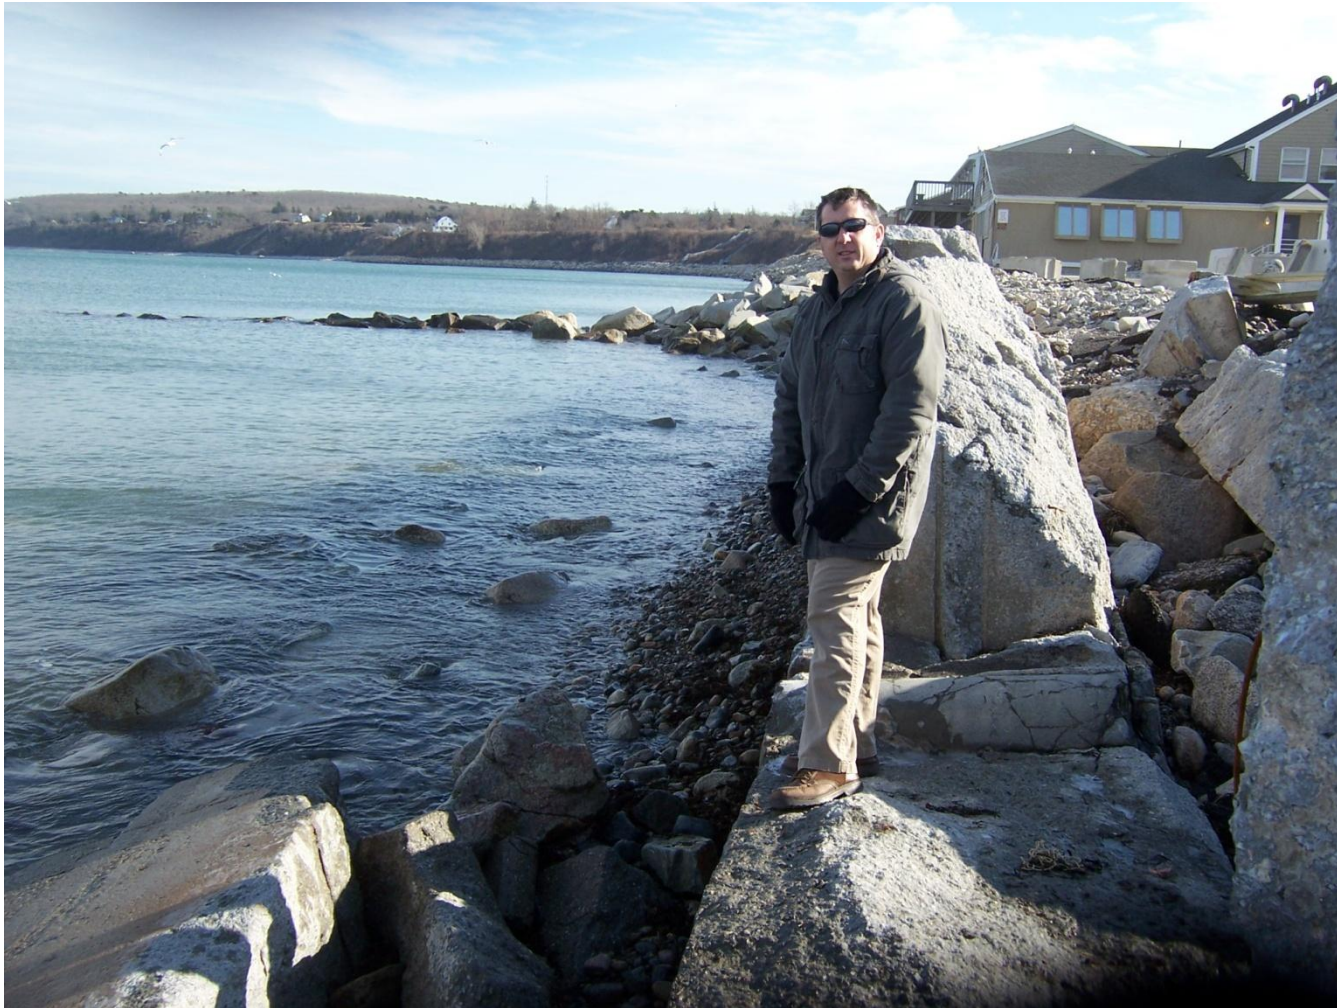
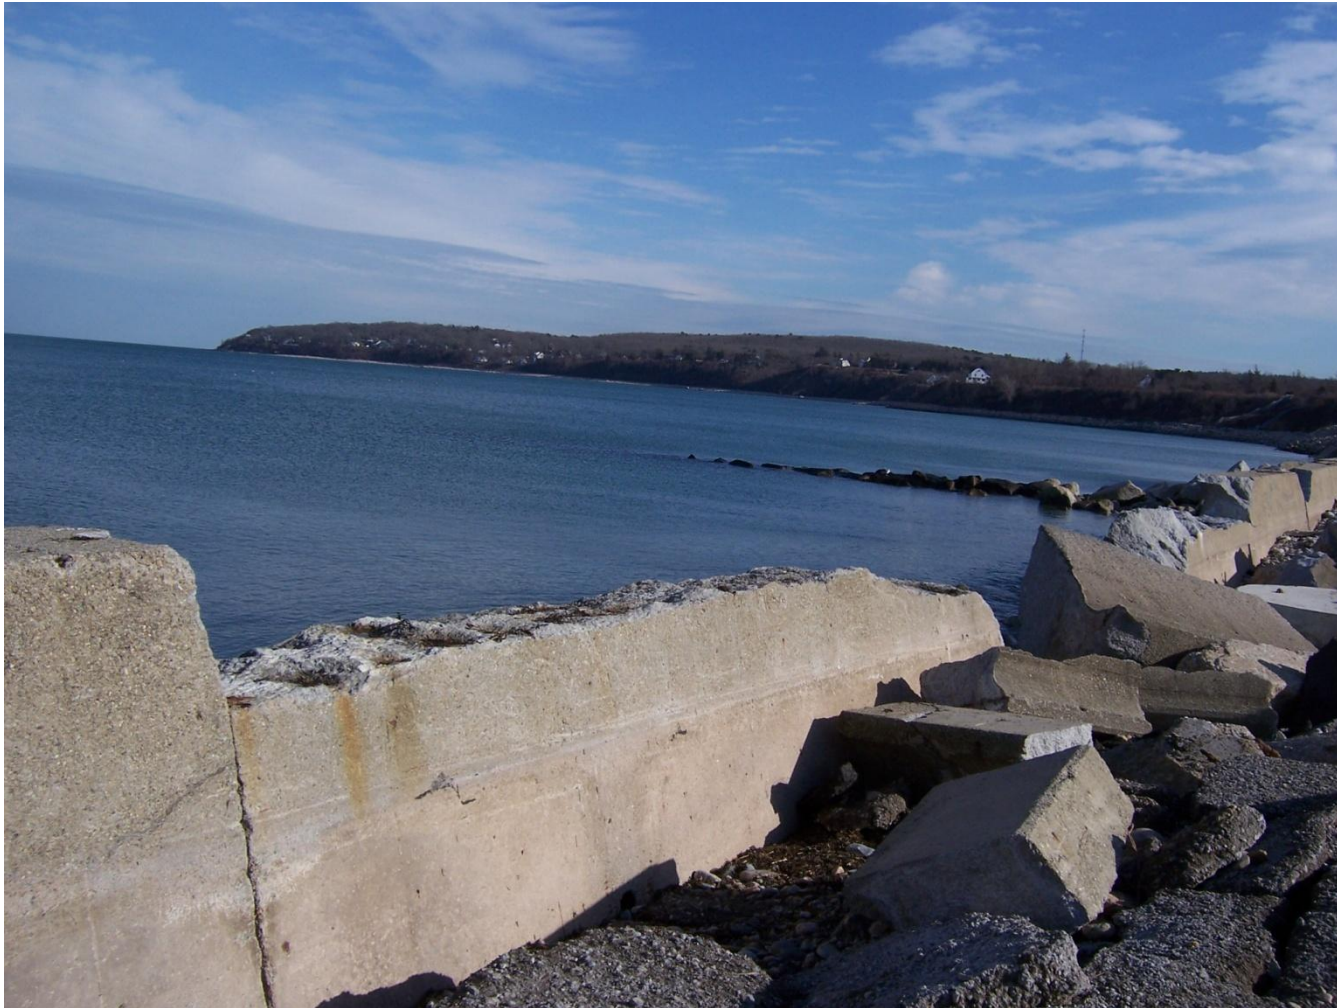
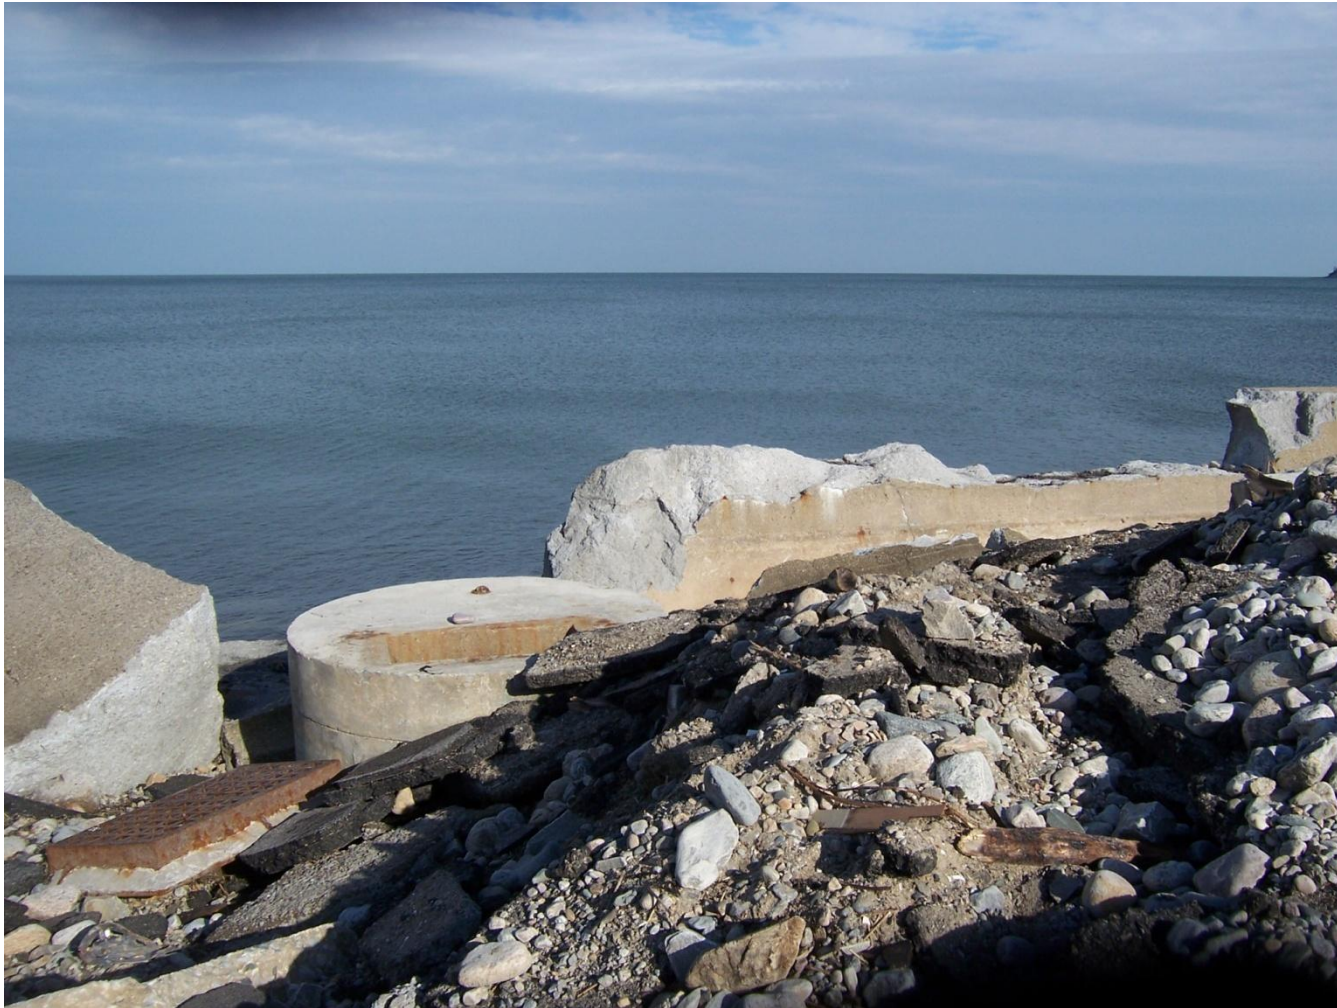
2010 Seawall Failure

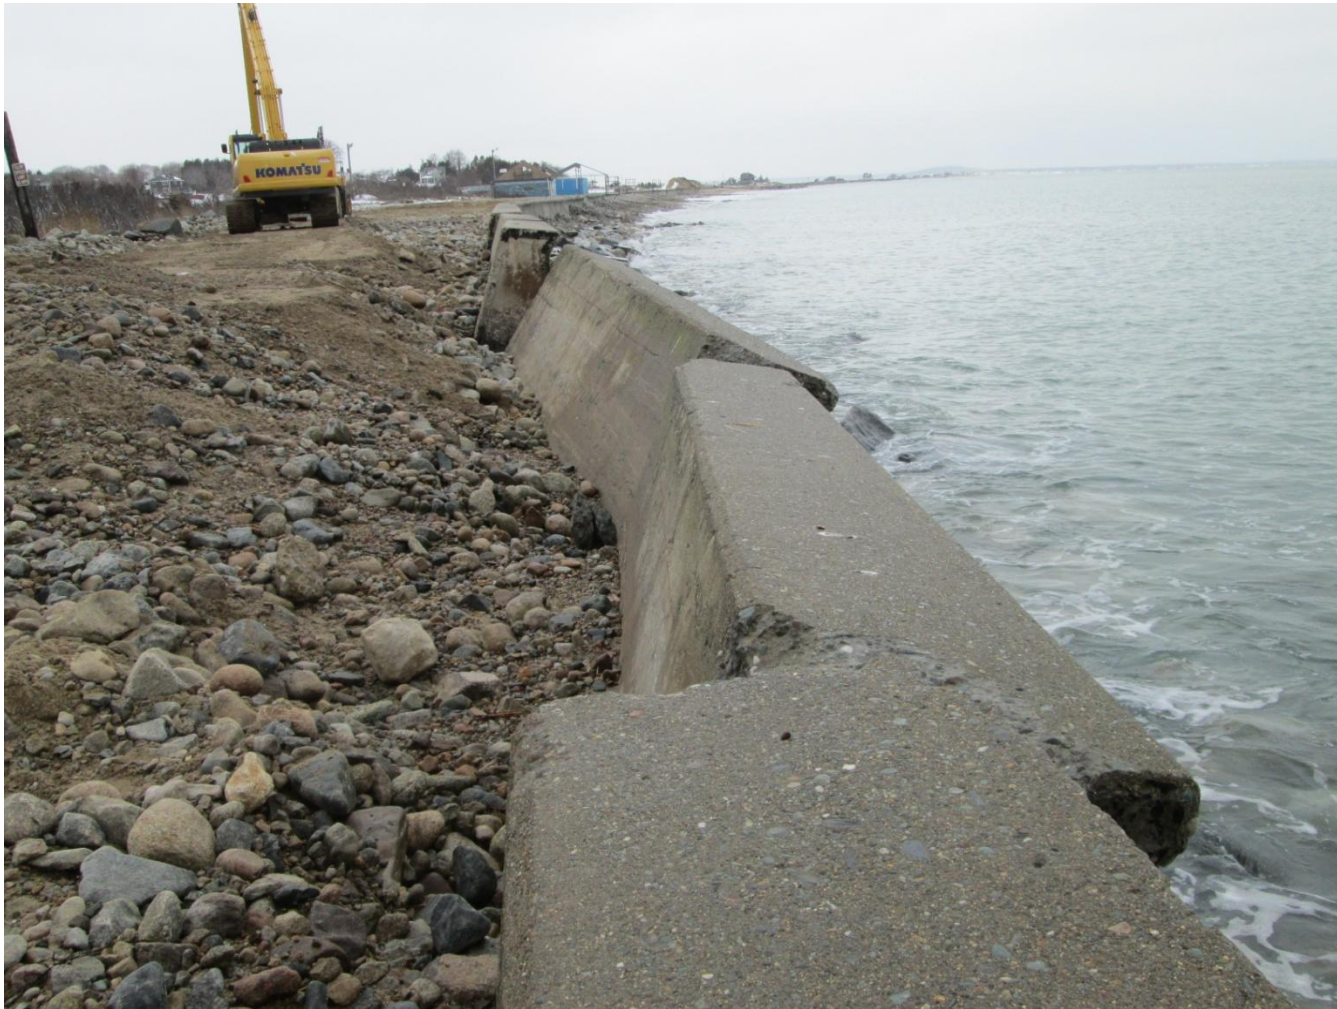
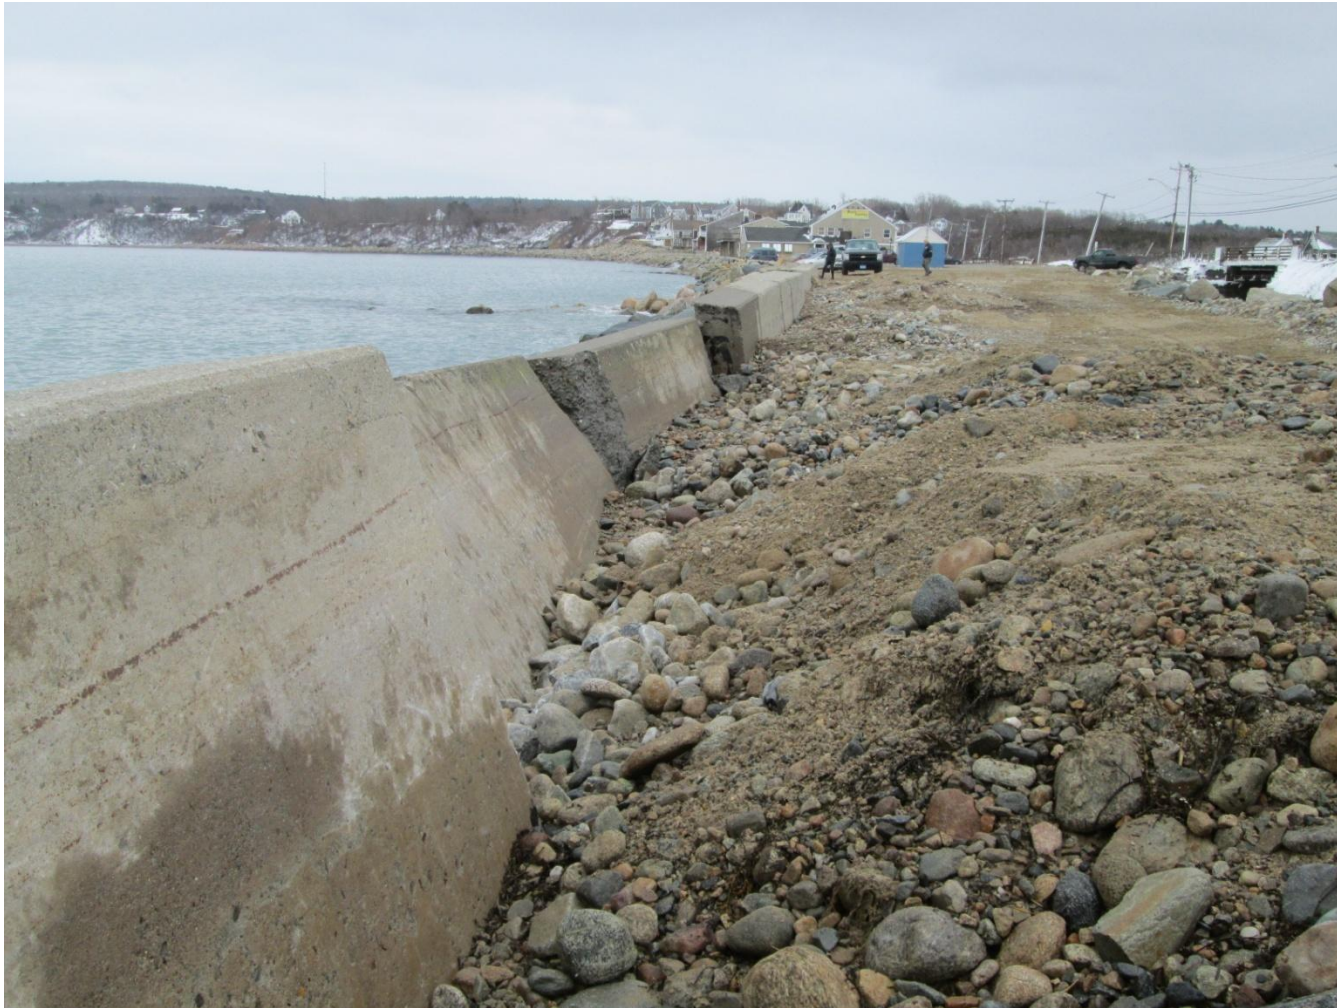
2016 Seawall Failure

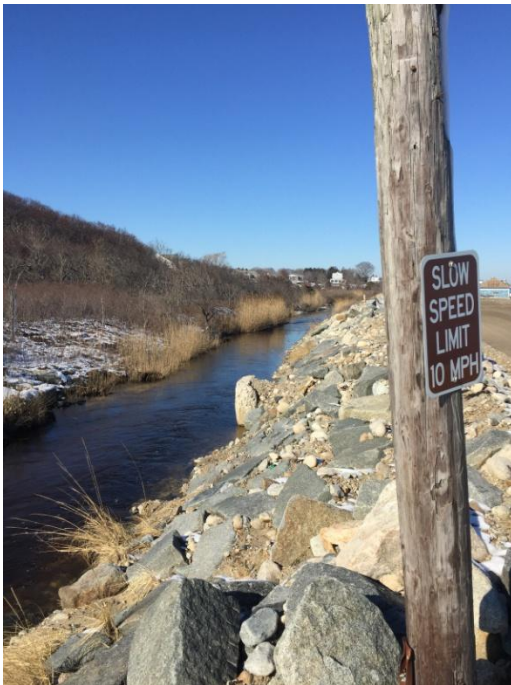
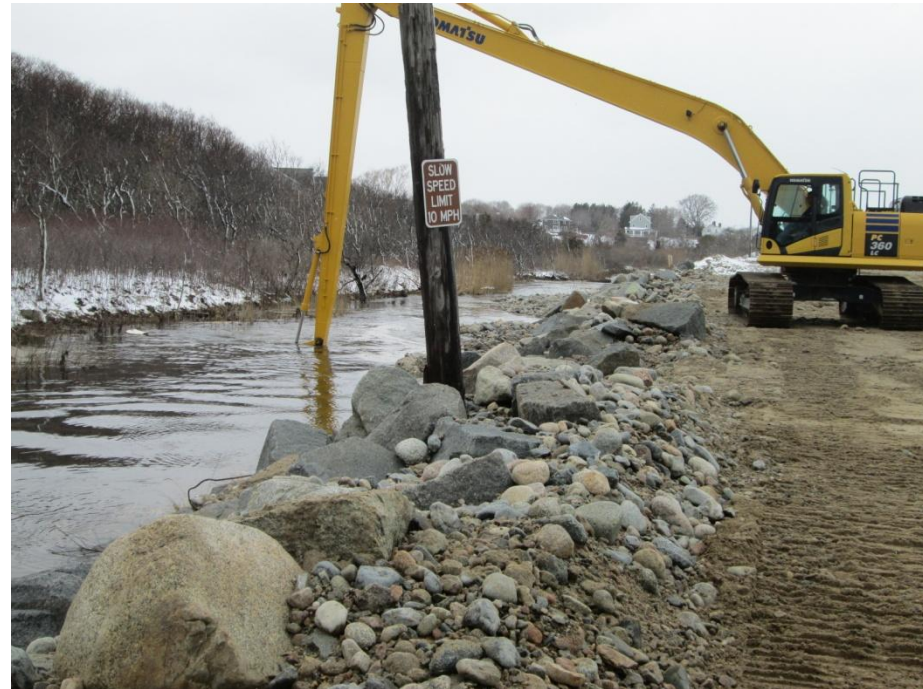
- Storms wash parking lot material into the river, causing flooding to upstream properties.
- Filling of the river and subsequent dredging can damage the stream channel and important fish habitat.

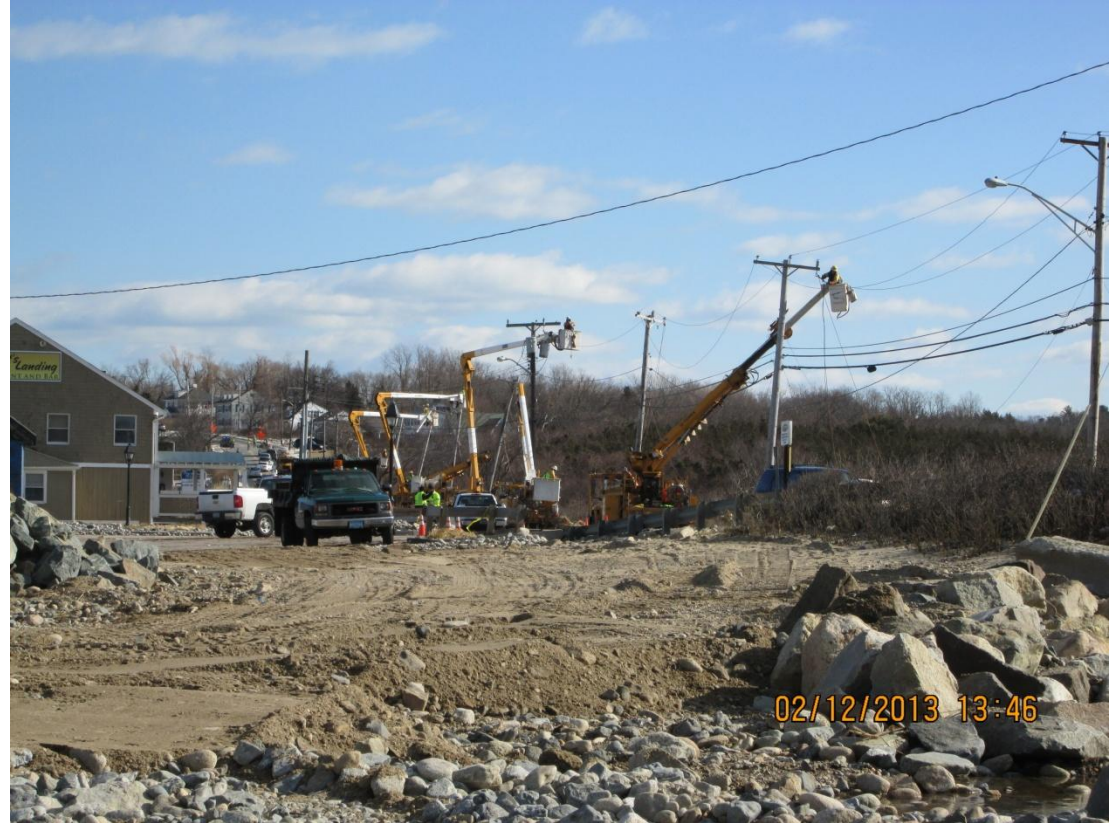
- Main route for travel, emergency response and evacuations
- Flooding and closures during coastal storms
- Damage to road and utilities

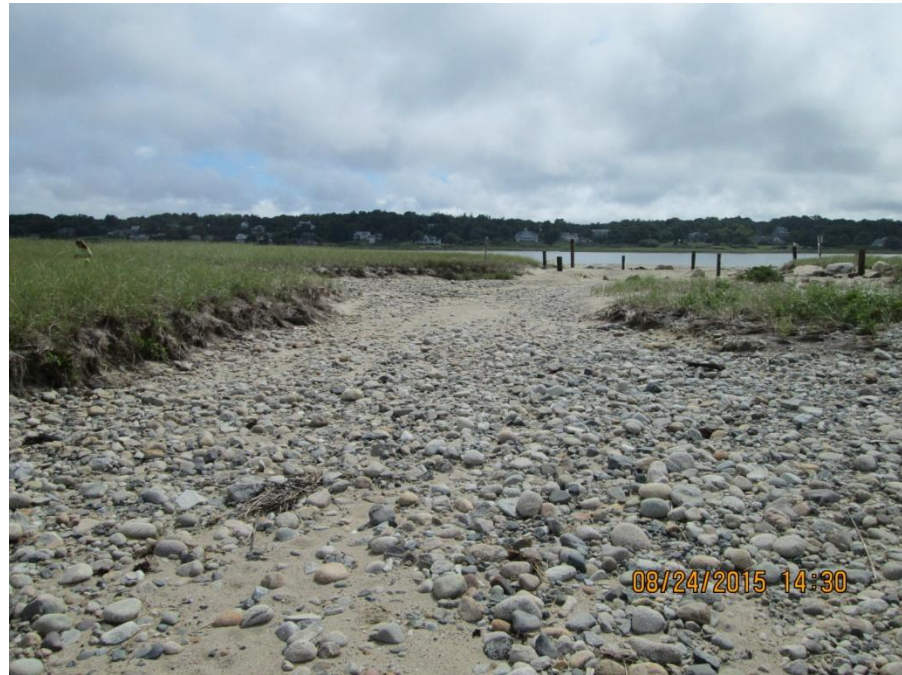
- No beach in front of stone dike in southern part of beach
- Wave energy is not dissipated at stone dike, water rushes over the beach to harborside
- Funnel effect in eroded overwash areas leads to increased water velocity and further erosion

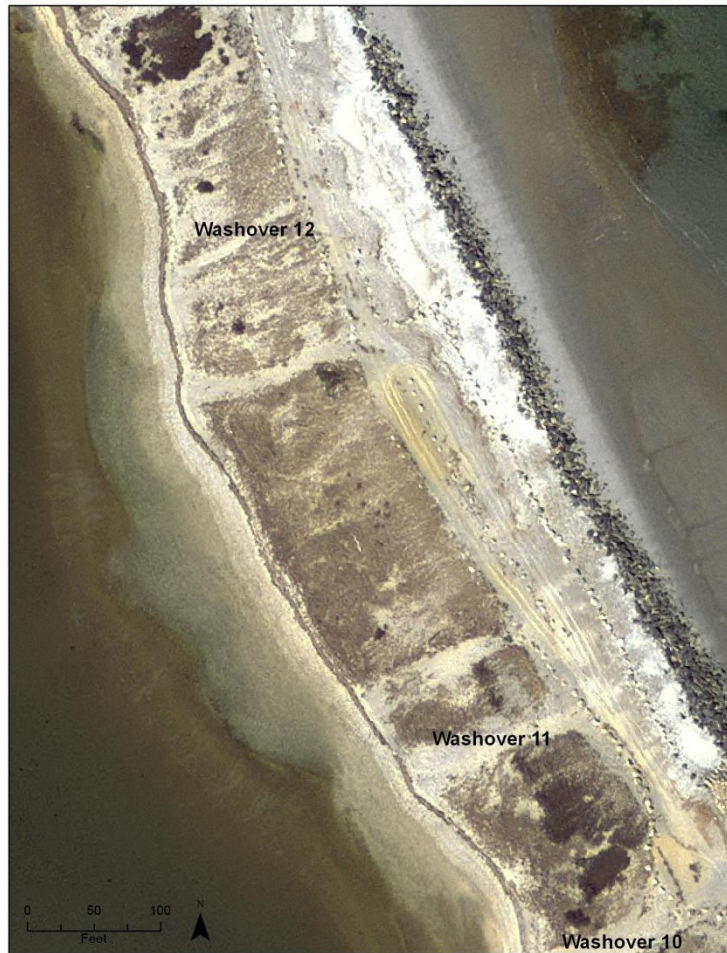
2008

Eroded Overwash Areas at Long Beach

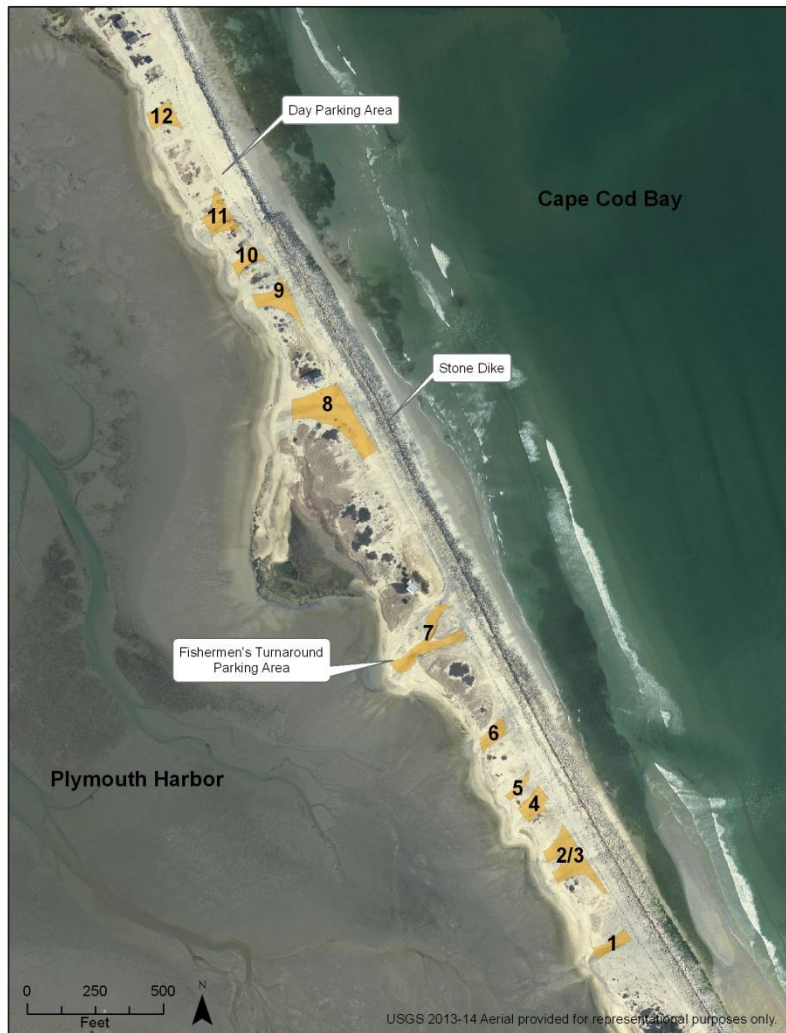
- 11 project areas
- Permitting by Dept Marine & Environmental Affairs
- Constructed by the Department of Public Works
- \$441,756 - Funded through a CZM Green Infrastructure Grant (37% Town match)

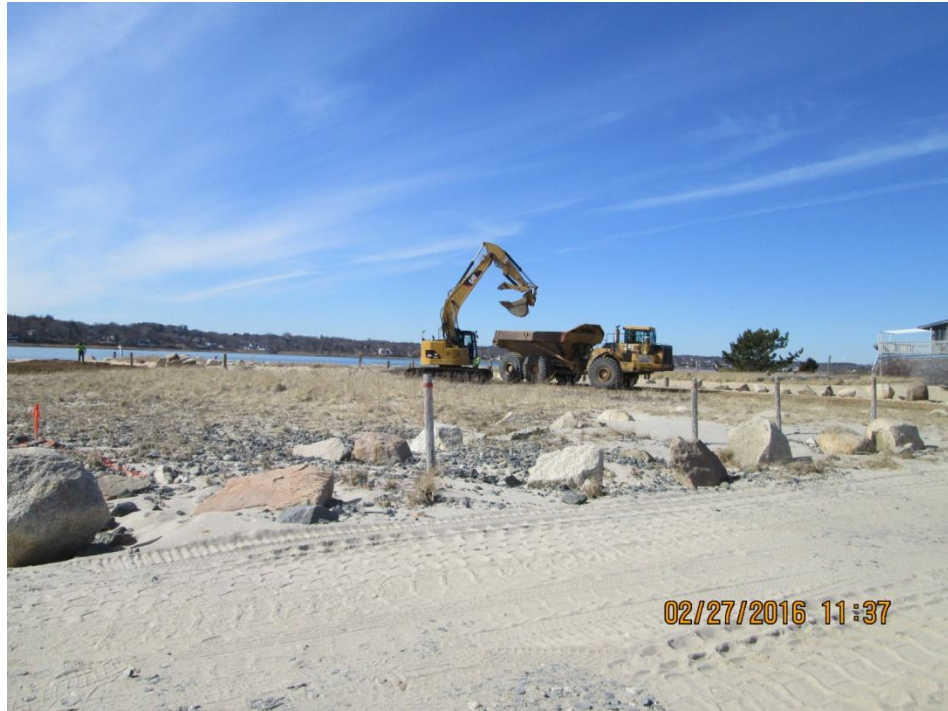
- Brought eroded overwash areas up to grade of surrounding areas.
- Used a mix of sand, gravel and cobble similar to the substrate in the eroded areas
- Greater longevity compared to sand alone

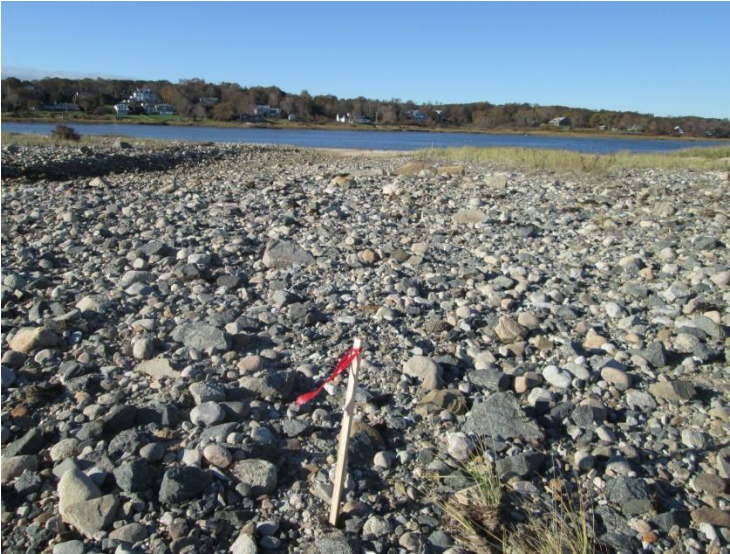
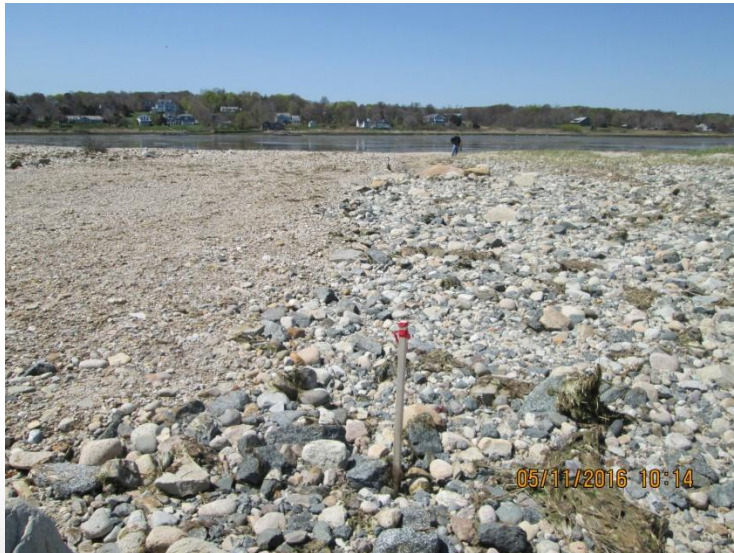
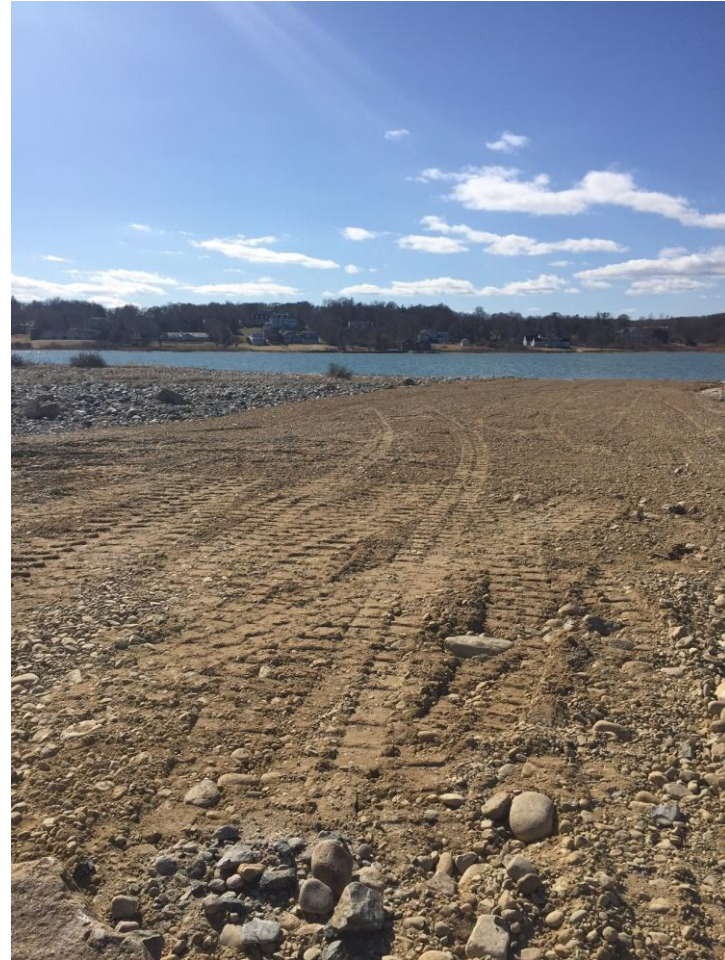
Project Area 1

Nourishment of Overwash Areas
